R/V Sally Ride Cruise SR1603 Chief Scientist's Report

James H. Swift, UCSD Scripps Institution of Oceanography
11-20 August 2016

Observations re R/V Sally Ride August 2016

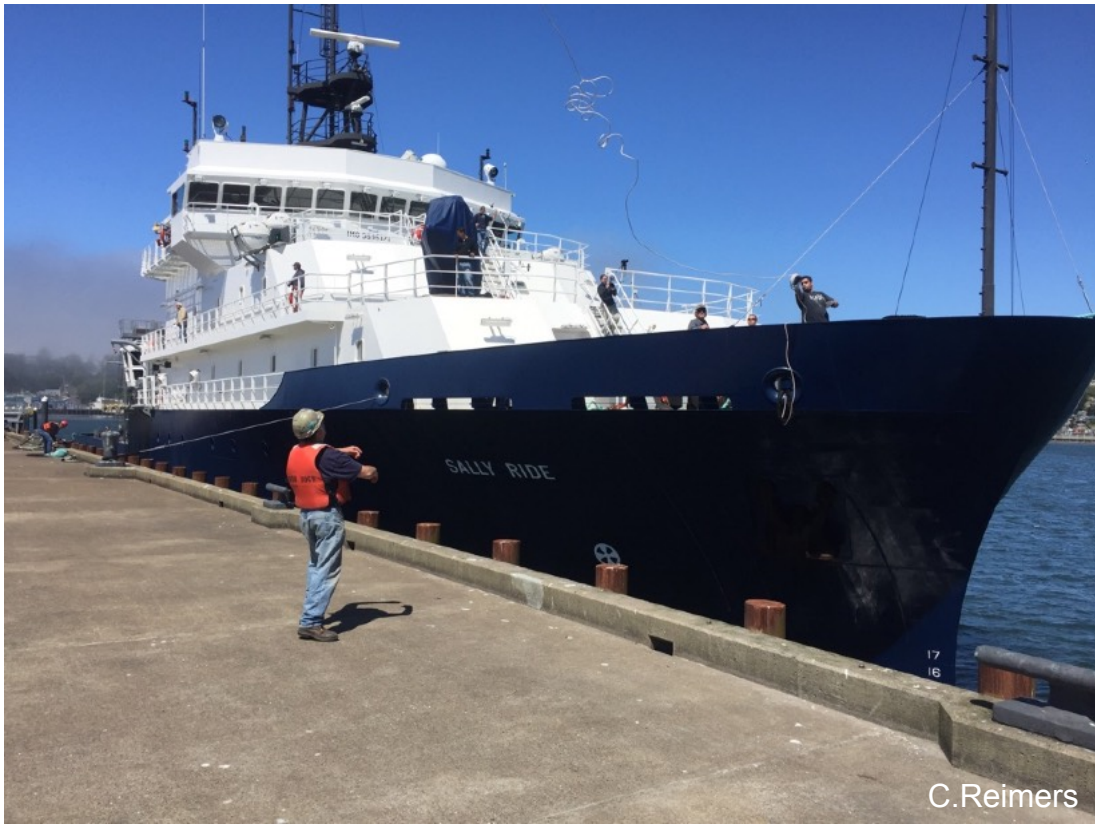
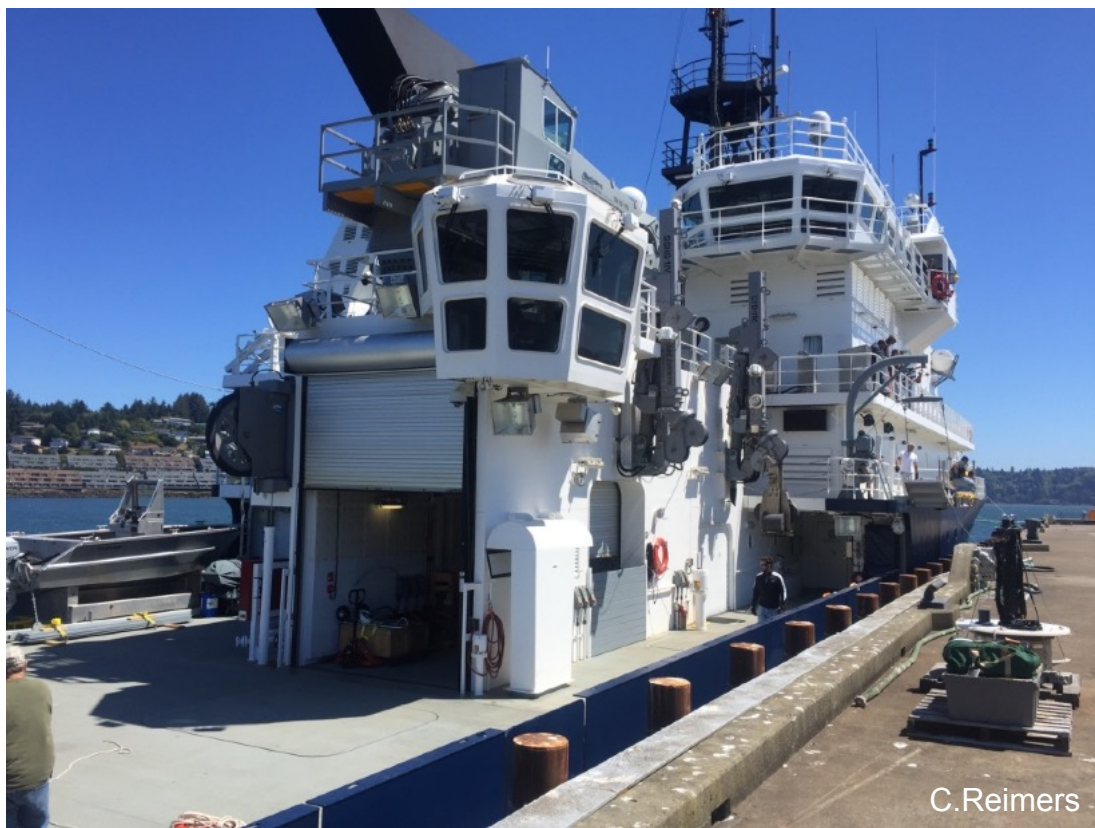
Figure 1. R/V Sally Ride exterior layout.

R/V Sally Ride has a traditional exterior layout (Figure 1). Notable features include a relatively clear fantail with (mostly) removable rails, a somewhat narrow starboard forward extension of the fantail deck, a large A-frame, two articulating/extending booms, a large crane, a staging bay with aft- and starboard-facing entrances, van hook ups, and a winch control station. The winch control station is large and comfortable, but its size and placement impede bridge views, and is inconvenient for crane operations. A winch operator in this station has at times a somewhat surprising less than ideal view of starboard operations.

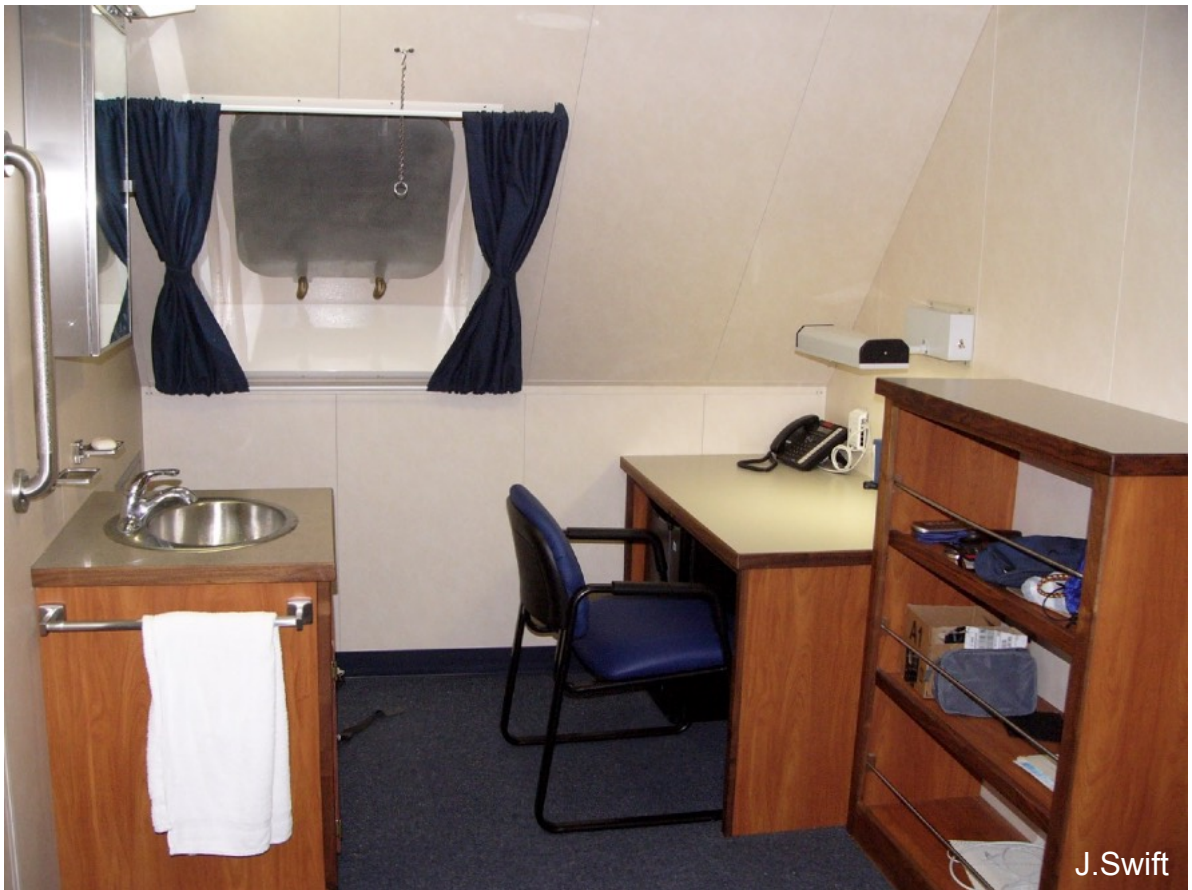
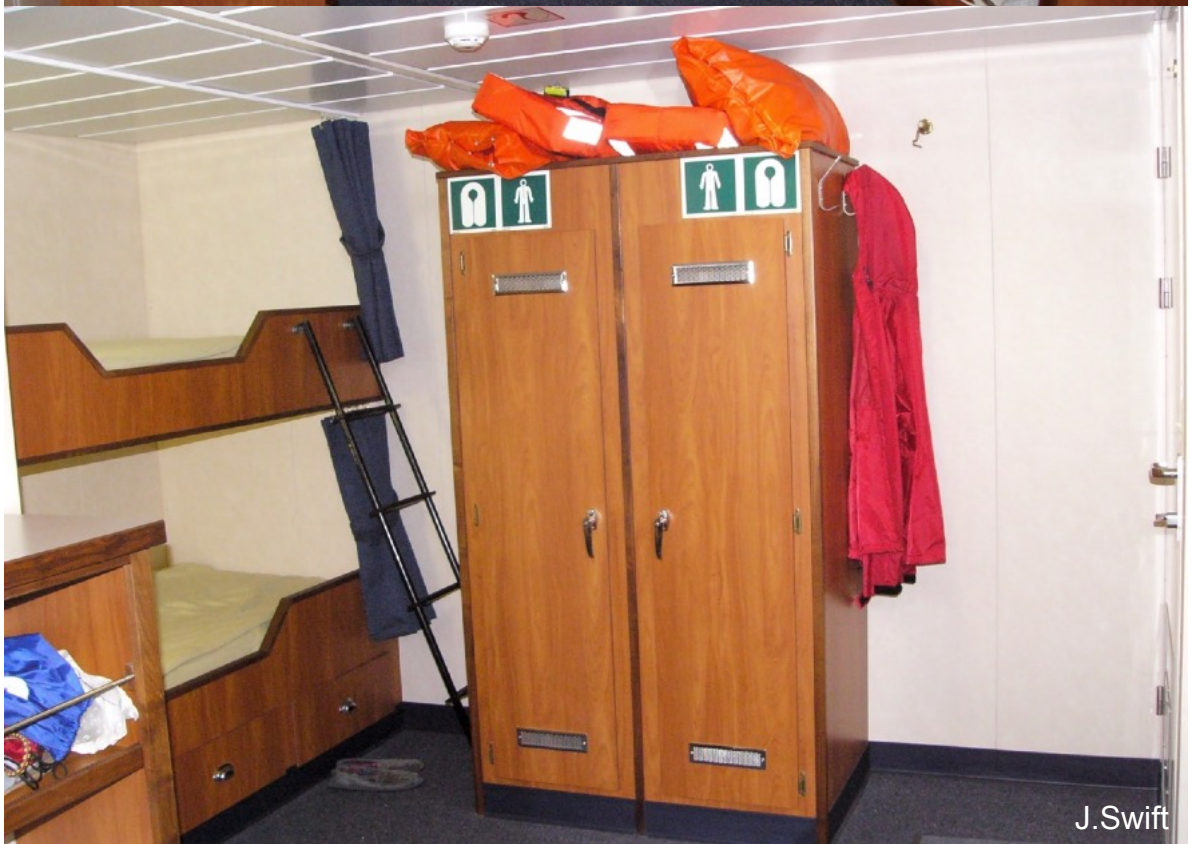
Figure 2. The stateroom assigned to the chief scientist.

My stateroom (FD-1) was spacious, quiet, and comfortable (Figure 2) as were all others. It was one of the quietest staterooms I have yet experienced on a research ship. It was a pleasant surprise to find wooden furniture in the stateroom (no rattling metal), and carpeted floor. Throughout the ship, false ceilings and attractive, neutral-colored wall panels add to the comfortable, well-finished ambience. But the stateroom was short on storage space: There was only one storage drawer per person in the stateroom (under the bunks), plus a closet unit (for hanging, with shelf above, but no drawers in it). While there is a desk, there are no drawers with it. There is a mini-fridge (why is this needed?) under the desk that should have been desk drawers. The (nice) three shelf bookcase unit (which has some provision to block items from falling out during rolls) will have to do for most storage. The mirrored cabinet above sink is adequate for toiletries. There is a bungee cord to secure the desk chair. There are no tie-down fittings to use to secure luggage and boxes, though there was adequate space in that stateroom to store such items.

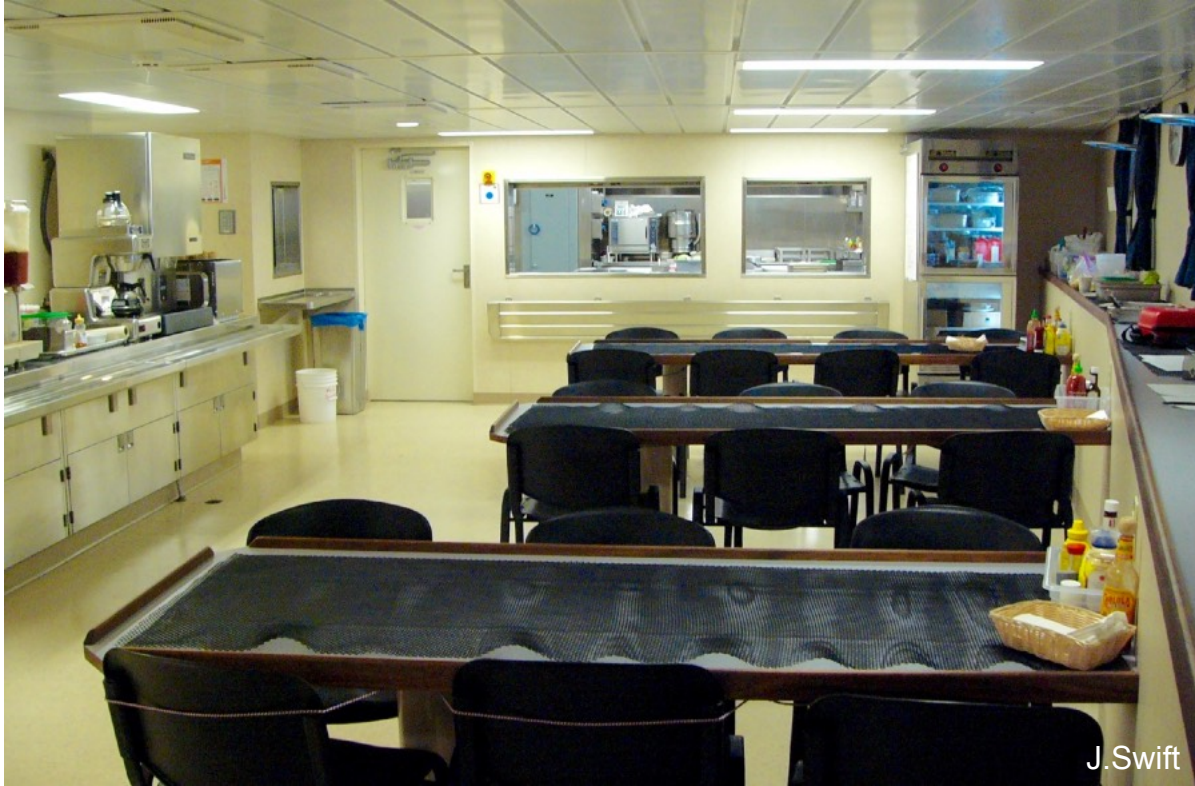
Figure 3. Mess Room

The mess room is spacious and welcoming (Figure 3), and can seat 24 at a time. It appears to have extra (unused) space. (Could extra seating be added?) It is well outfitted in the SIO style. The food on board is to the usual excellent SIO standard, meaning cheerfully prepared hearty, tasty, fresh, wholesome meals (and tasty treats) much enjoyed by all hands. The variety, quality, and quantity of food prepared and served by the two cooks (George and Mark) was excellent. They have use of a dumbwaiter which serves the mess room and the food storage area below the main deck. There was a vast array of foods available 24/7 including drinks, leftovers, cereal, sandwich makings, snack foods, ice cream treats, etc. There was no soda dispensing machine (as there was on R/Vs Melville and Reville), but considering health concerns, that may be a step in the right direction. A more serious omission is that there was no sink: hand washing must take place in a public head opposite (slightly forward) of the mess room door, and there is no place to dump extra drinks from mugs and glasses. There was no hand sanitizer station in the mess room. (Ideally there should be one placed before one touches anything else in the mess room.) There is only one normal service door into the mess room, at the galley (aft) end of the room. If a serious galley fire erupted during a meal, rapidly pouring smoke into the mess room, would that pose a safety (exit) hazard? If I recall correctly there was only one EBBD in the mess room. On looking hard, I did find that there is an emergency ladder (a vertical ladder) from a dry stores room reached through a door at the forward end of the mess room. There was a very small "Escape" sign on the door leading to it from the mess room. It is too small to be seen in an emergency. If this is indeed an intended emergency exit from the mess, there should be a large, easily seen, glow-in-the-dark "emergency exit" sign on the door leading to that ladder.

Regarding EBBDs, I recommend that one per passenger be placed in the staterooms. I also recommend that each interior space on the ship be evaluated for ease of egress to the exterior during a smoky fire, with an eye to placing additional EBBDs where there might be concentrations of personnel who would not have direct/rapid access to the exterior.

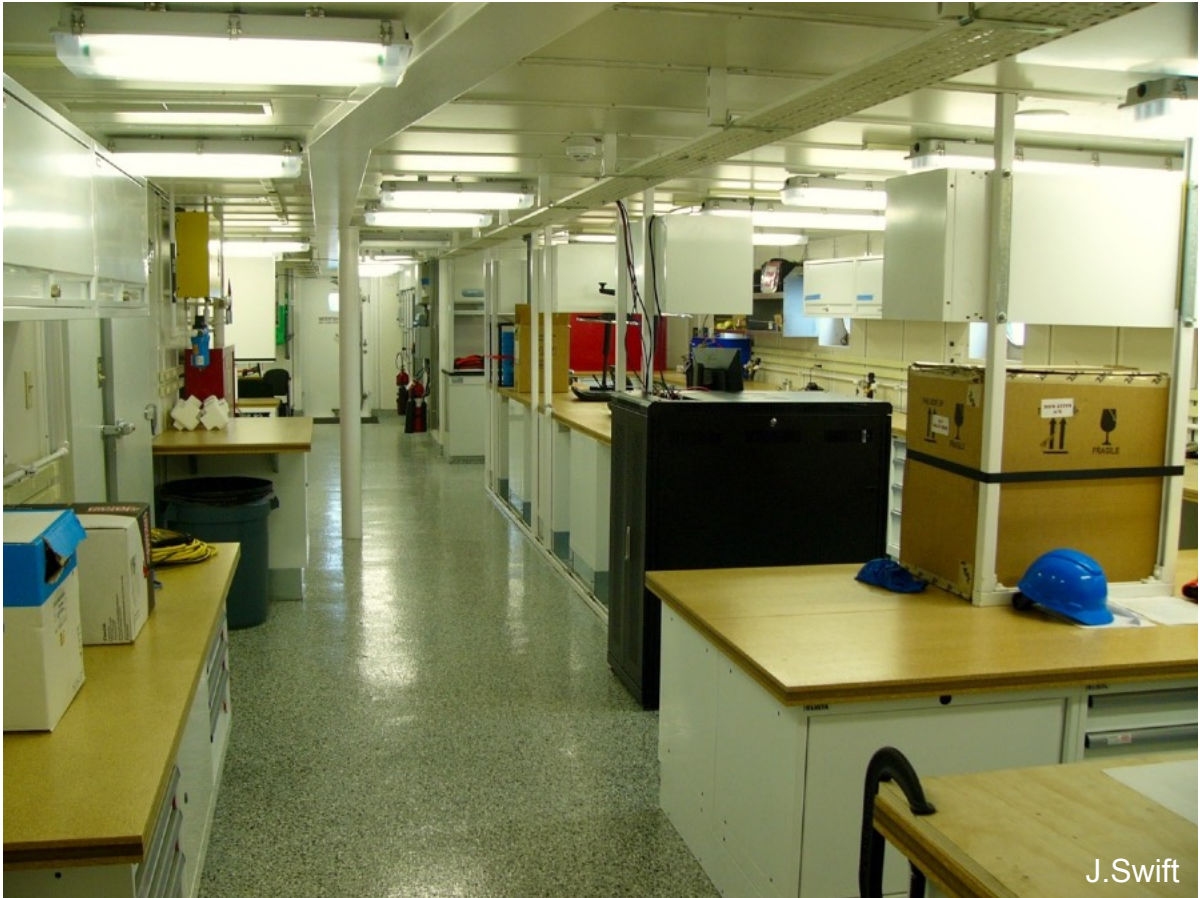
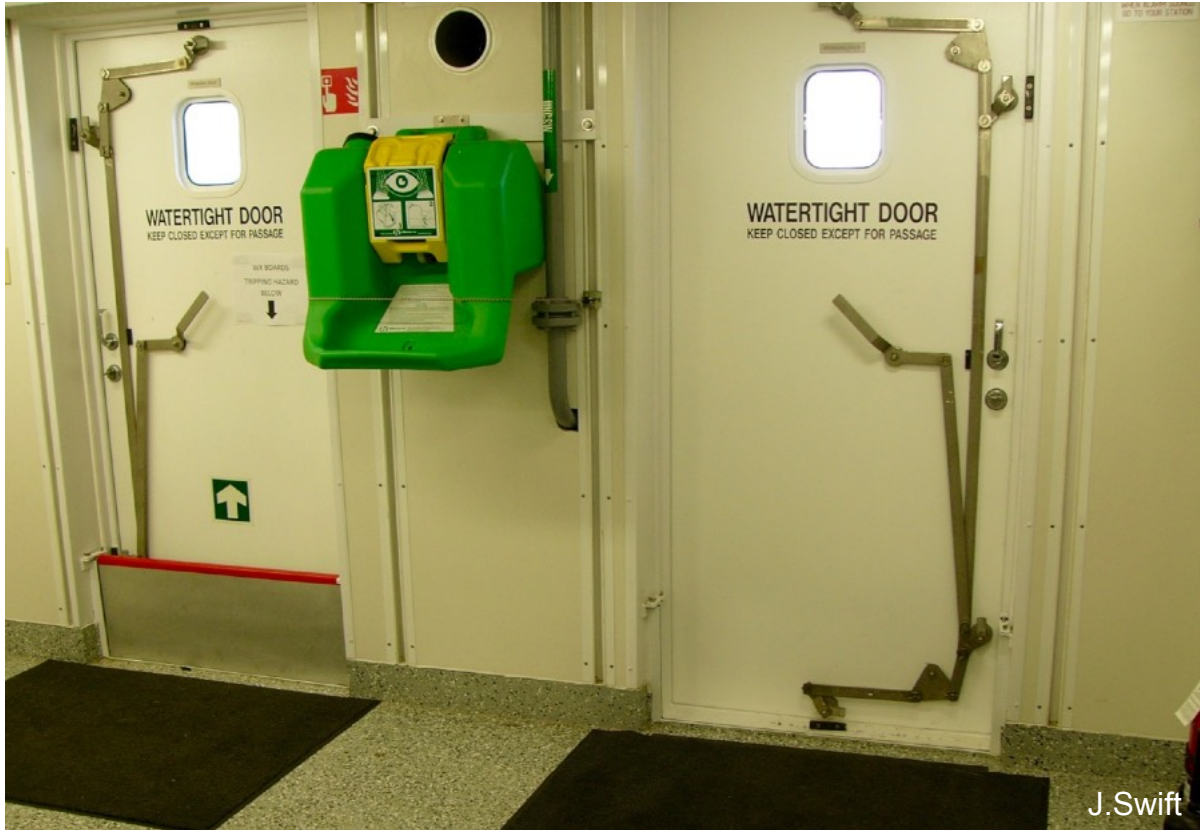
Figure 4. Main Lab (including detail of aft doors).

The main lab (Figure 4) is good sized. There is adequate room for personnel to move around any portion of the lab when the lab is full and busy, with wider passages in the areas of the lab where personnel would be traversing to the fantail, wet lab, or staging bay. (The ship's central corridor does not extend through the lab areas. To reach the fantail from the forward areas of the main deck one must go through the mud room - which has aft exits to the starboard fantail deck and to the wet lab - or the main lab, with the main lab route more practical for many purposes.) There are two hoods (mounted on phenolic bench tops), a side-by-side pair of deep stainless sinks (mounted on a pressed/manufactured wood bench top and adjacent to one of the hoods), two pairs of outlets & drains for the uncontaminated seawater system (one pair of which is adjacent to both a hood and the double sink), over 135 feet of benches, numerous (too numerous?) cabinets above and under the benches, ubiquitous 2-foot unistrut and deck bolt fittings, cable trays, many power outlets, many data ports, wireless, a flammable liquid storage cabinet, and compressed air outlets. There is a metal tank (unknown lining material, if any) for storage of distilled water which is pumped from a small evaporator in the engine room. The science information and control center, with its many monitors, has not yet been installed, but will go into the forward portion of the main lab. That space should work well for it in terms of utility to the science team. There is a cluster of four special power outlets: two 208-volt and two 240-volt. There is a rack for 4 gas cylinders. There is access to a $\approx 6' \times 7'$ walk-in refrigerator (or freezer - user can set any temperature within a useful range; with a light and an emergency call button but no power outlets, data ports, etc.) with ample wire-type shelving (which preserves good air circulation). The doors to the fantail from the main lab are two separate single doors, nearly flush to deck, each with usable size ca. 36" W by 78" H. There are also doors to the staging bay, wet lab, and main corridor. The watertight doors from the main lab to the fantail have dogging levers that can be a real challenge to operate - is this a possible safety issue for science personnel in emergency situations?

Figure 4. The main lab. Note that although the lab furniture is attractive and sturdy, it is less versatile than the easily customized "erector set" lab benches with quickly-replaced plywood tops which are typical on SIO's research ships. SIO has had to cover the bench tops in present use with clamped-on plywood to provide tie-downs.

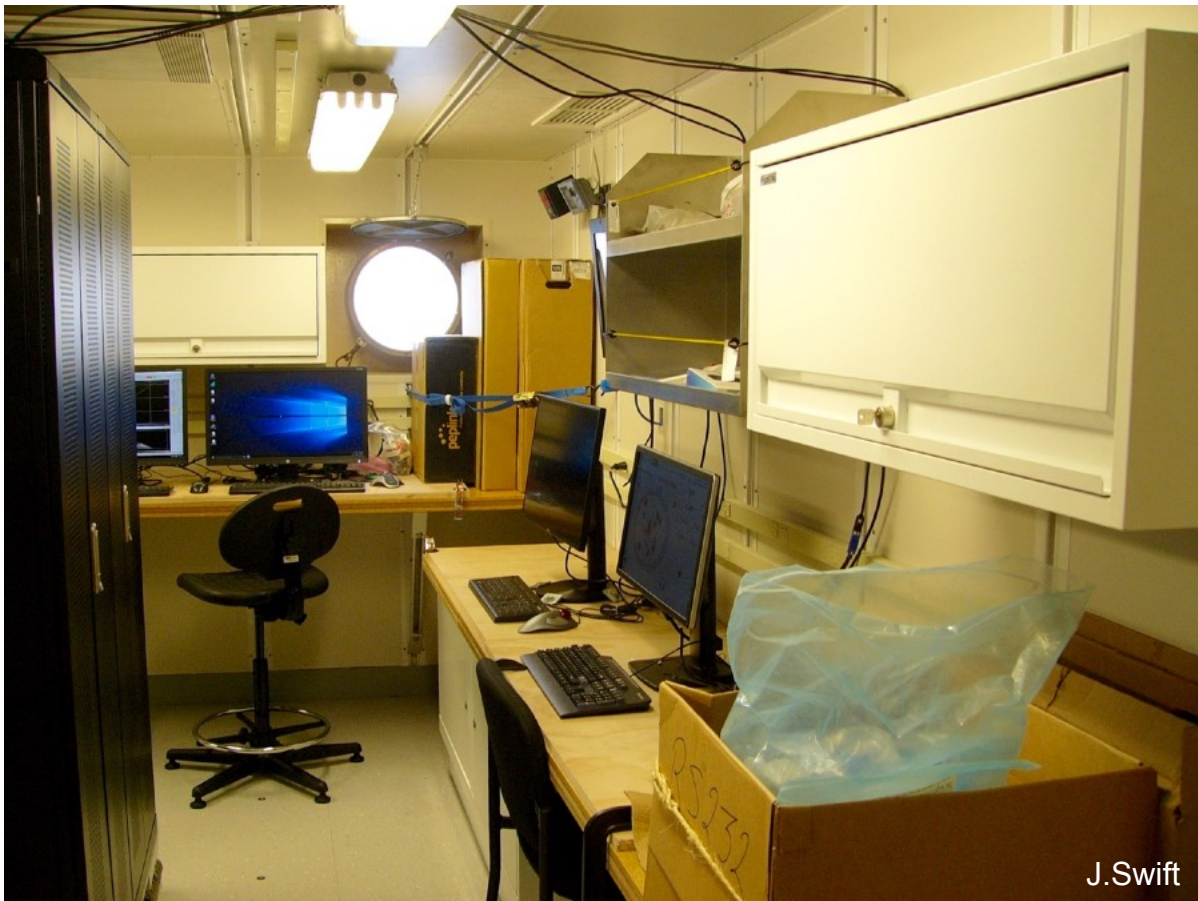
Figure 5. Computer/Electronics Lab

The computer/electronics lab (Figure 5) is small for its many functions, and has large electronics cabinets filling much of its interior, blocking the center of the lab. While this makes for easy access to the electronics in the cabinets, it does not make the lab an inviting place to work. It will be a tight space for any cluster of science team members gathered to see the latest data real time (for example to make sampling decisions). (If there are repeater displays in the forward end of the main lab that may suffice for that purpose.) There are approximately 34 feet of bench, plus numerous cabinets above and under the benches. There are many power and data outlets, good lighting, bulkhead paneling, etc. as in the main lab. There is a temperature control similar to the ones in staterooms, which is useful for keeping the computer lab cool. (The computer lab was appropriately cool, yet not uncomfortably cold as it is on the Revelle and many other ships.) There are a pair of lip-free 40" "one-and-a-half" doors across the main corridor between the computer and main labs, and a standard 3' door to the lounge.

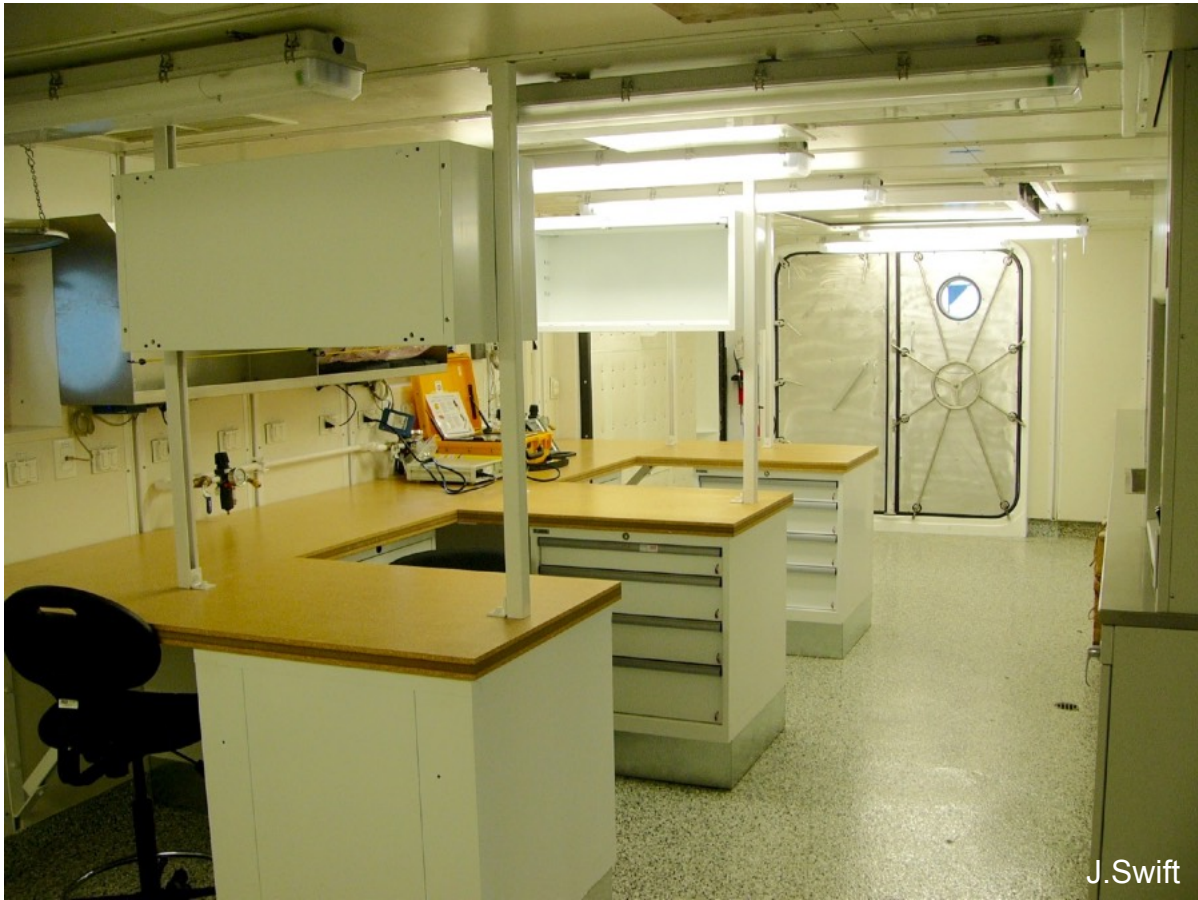
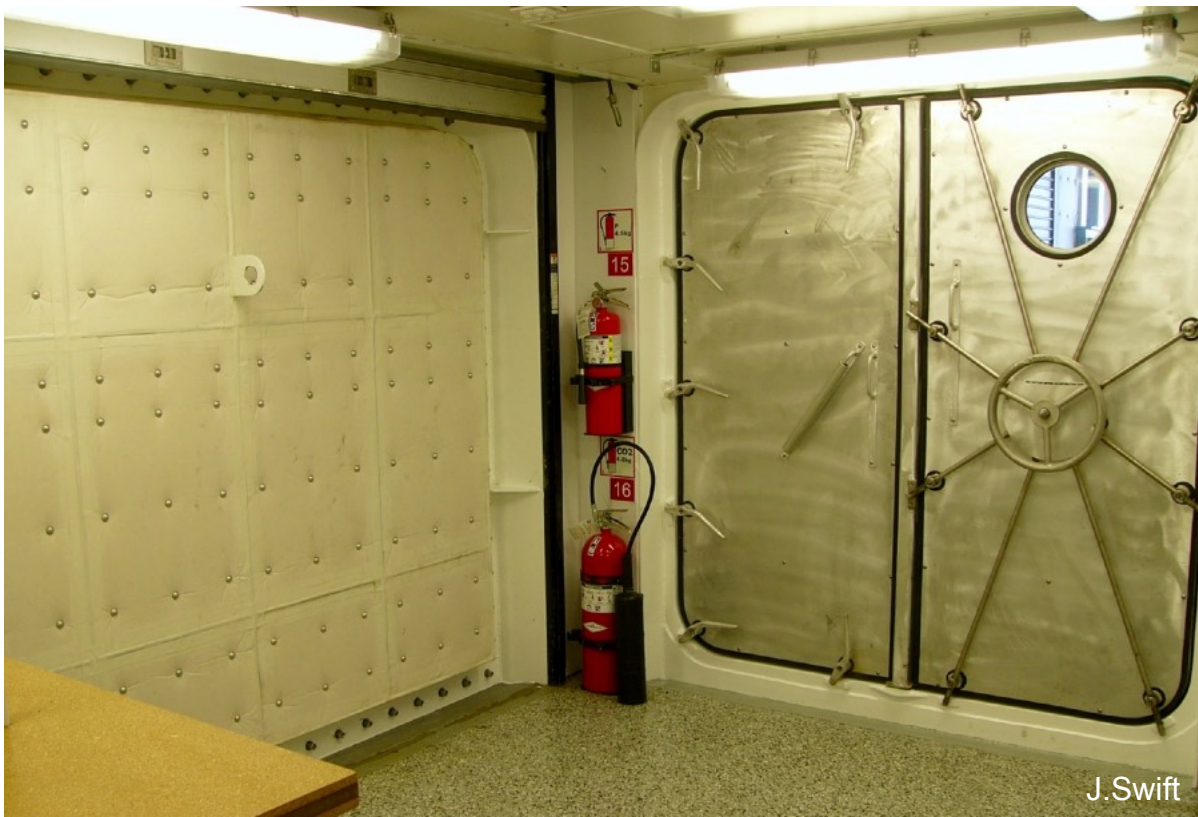
Figure 6. Wet Lab

The wet lab (Figure 6) is similar in many respects of its outfitting and appearance to the main lab (though smaller), except that its doors to other ship's spaces are watertight doors, and its stainless sink (single) and hood (single) are mounted on a long stainless bench top. The wet lab has a large open area (ca. 8' x 9' useable deck space) adjacent to an aft-deck-facing double doorway with usable size ca. 72" W and 78" H and 5" lip, and a now-sealed-off opening to the starboard deck approximately 88" W x 78" tall. (It is not clear if that opening would be flush to the deck if that seal panel were removed, but it appears that it would not be flush, i.e. that there would be a small (2"?) sill.) There is a roll down "garage door" for the now-closed-off opening. There is a nearly flush-to-deck single watertight door from the wet lab to the main lab with usable size ca. 40" W and 78" H, and a no-lip 36" watertight door to the mud room (which has a no-lip door to the main corridor). There is no special deck drain near the large open area where wet equipment might be brought in, or, conceivably, water sampling might take place, only the small deck drain at the sink (as in the main lab). (This could be a significant problem.) There are $\approx 26'$ of wooden bench tops and $\approx 14'$ of stainless bench top (not including the large, deep stainless sink built into that bench, or the bench top under the hood). There are numerous cabinets (too numerous?) above and below the bench tops. Power outlets (ample) are covered. Lighting, unistrut, deck bolt holes, compressed air, data ports, ceiling, and bulkhead paneling are similar to those in the main lab. There are two pairs of special electrical outlets: each has one 208-volt and one 240 volt outlet. There is access to a $\approx 6' \times 7'$ walk-in refrigerator (or freezer) identical the one off the main lab. (Each of the two is independently controlled.)

Figure 6. The wet lab is similar to the main lab (though smaller), except that its stainless sink and hood are mounted on a long stainless bench top. The wet lab features a 8'x9' open area adjacent to an aft-deck-facing double doorway and a now-sealed-off, flush-to-deck opening to the starboard deck. There is no deck drain in that open area.

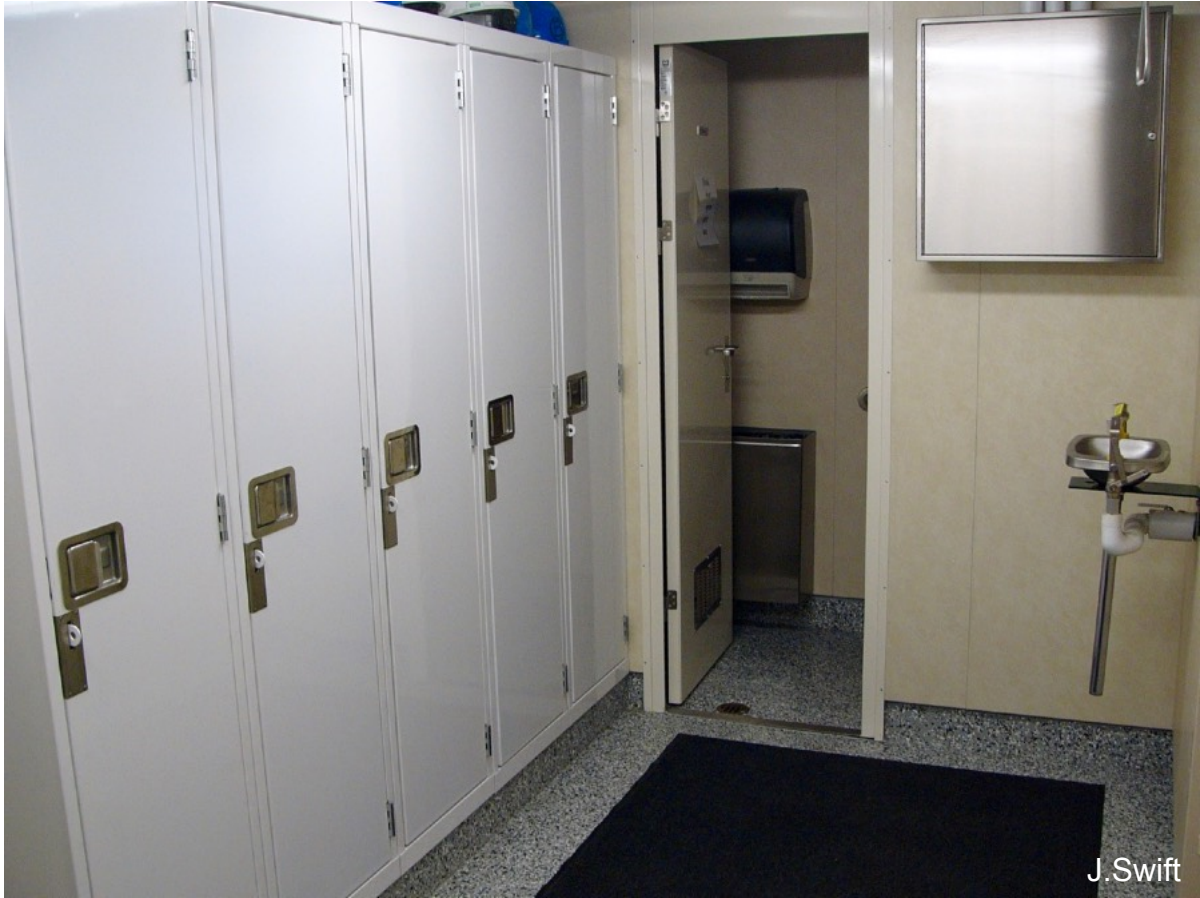
Figure 7. Mud Room

There is a mud room (forward of the wet lab, which in turn is forward of the staging bay) for boots and weather gear (Figure 7), but much of its bulkhead space is taken by five lockers and other permanent installations such as a chemical eye bath and shower. If the lockers are claimed by the crew and research techs (which seems likely and appropriate), it is not clear there will be any space there for the science team's boots and foul weather gear. There are few places in the labs to place these items. Adding such places should be considered. There is a small public head off the mud room.

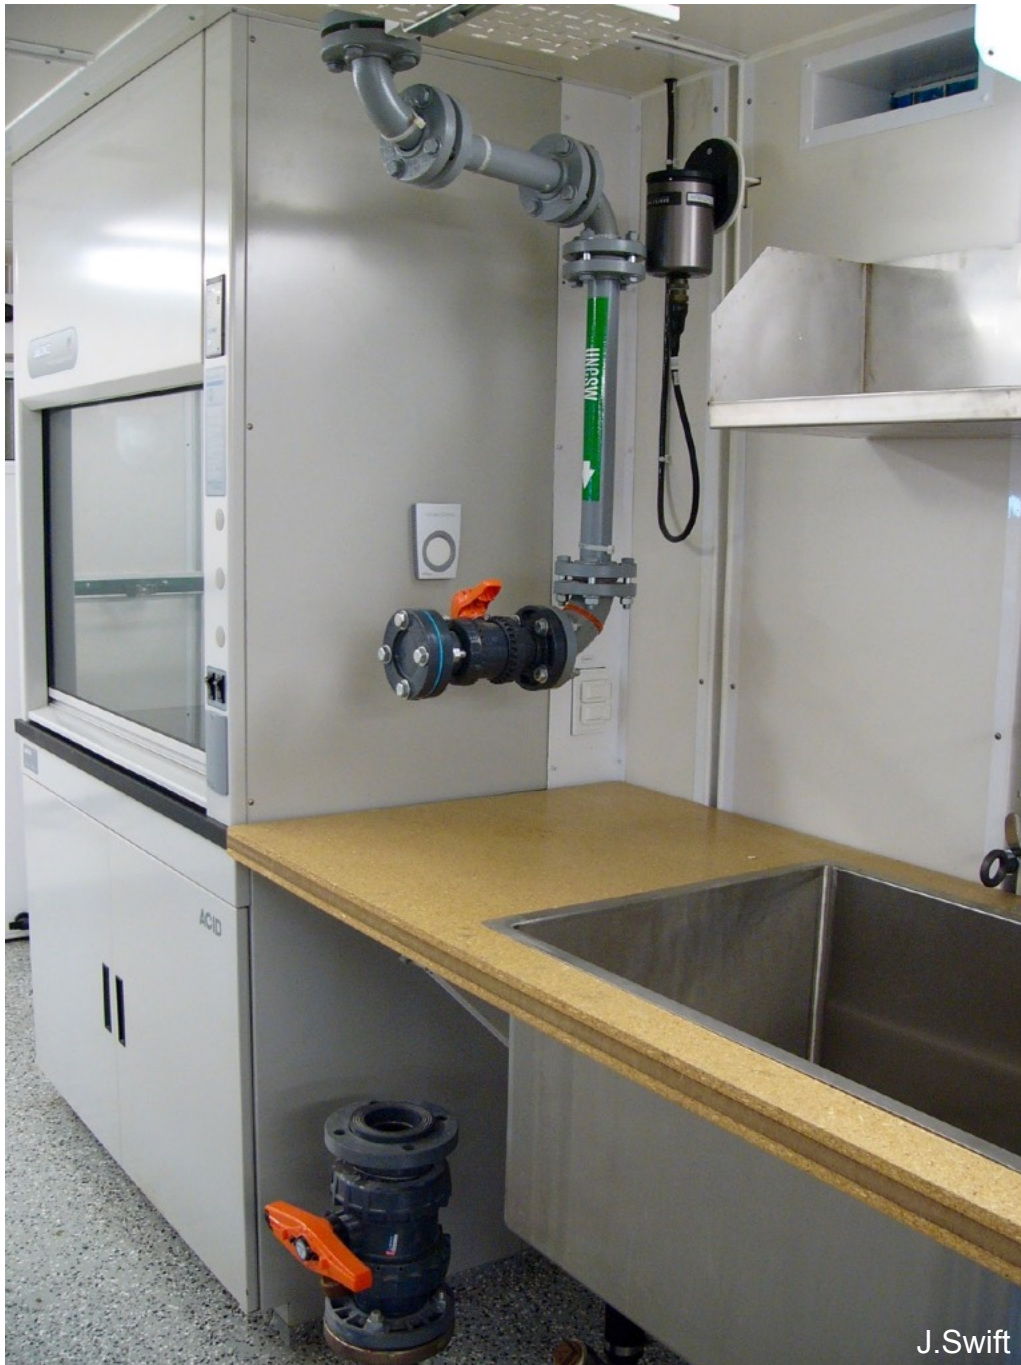
Figure 8. Outlet and Drain for the Uncontaminated Seawater System

There are outlets, each with a drain (e.g., Figure 8), for the uncontaminated seawater system in the wet lab, main lab (2), and for each of the three van connections on the fantail. There is a separate seawater pumping system for incubators with outlets on the fantail and on a forward deck area (drainage for those would be via hoses over the side).

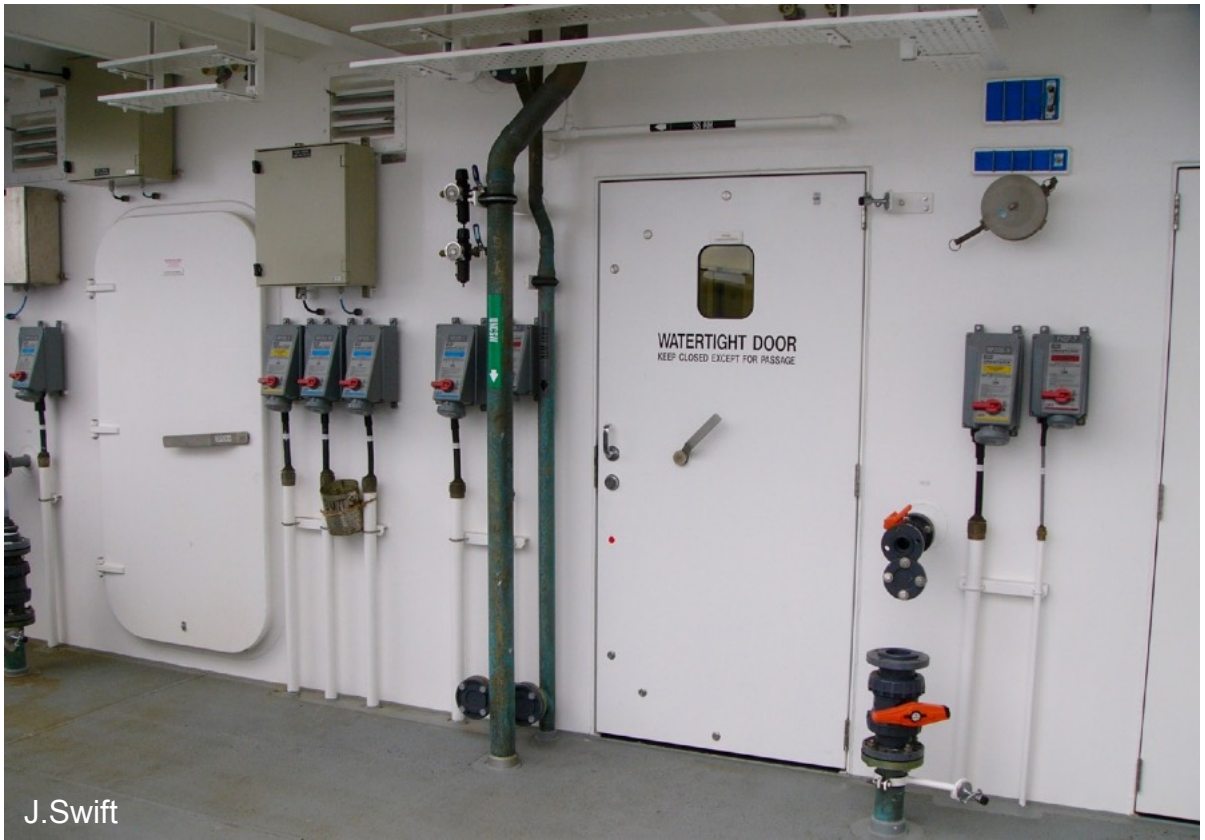
Figure 9. Laboratory Van Fittings

The van arrangements on the fantail are interesting. There are spaces and fittings for two vans on the fantail (port side forward; Figure 9), with fittings for a third van on top of one of the other two, with a work boat on its tie-down frame placed on top of the other van. But UNOLS lab (and berthing?) vans have their required emergency exits on the top of the vans - nothing can be placed on top of them. The configuration of one UNOLS lab van and one work boat is easily supported. If a storage van is added, it could be placed under either the work boat frame or the UNOLS lab van. To use two lab vans and one storage van, one lab van would be on top of the storage van, and the work boat would need to be installed elsewhere on the ship. The ship cannot currently support three vans with emergency exits on their tops. Each van hook-up point on the fantail (including the one on the forecastle deck just above the main deck van points) has data port, potable hot and cold water, grey water drain, uncontaminated seawater outlet and drain, and marine outlets for 120-volt (1), 240 volt (2), and 480-volt (1) electrical power.

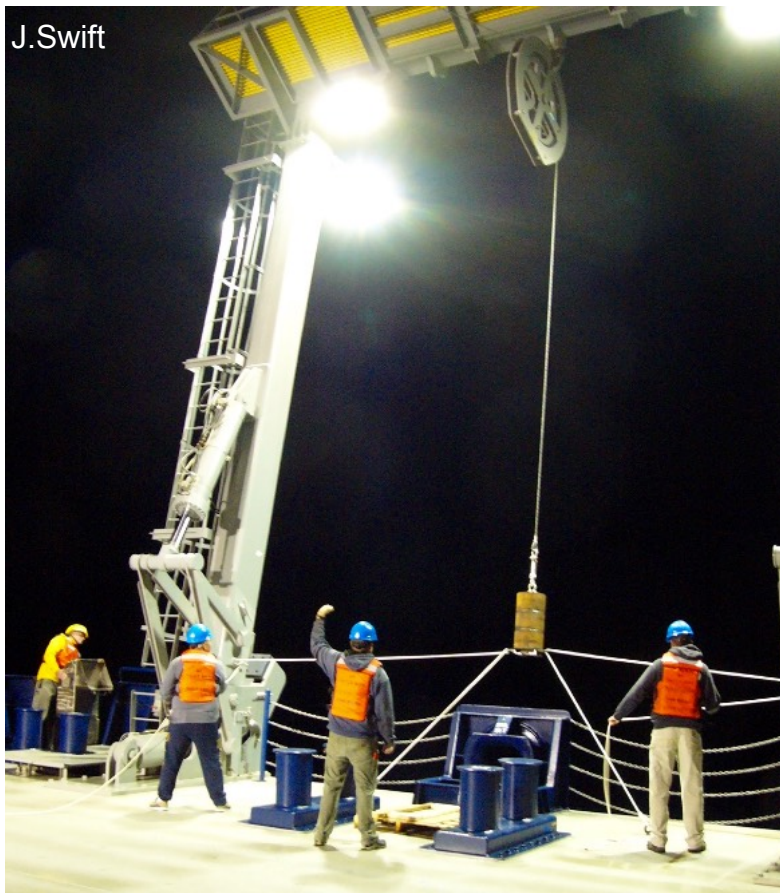
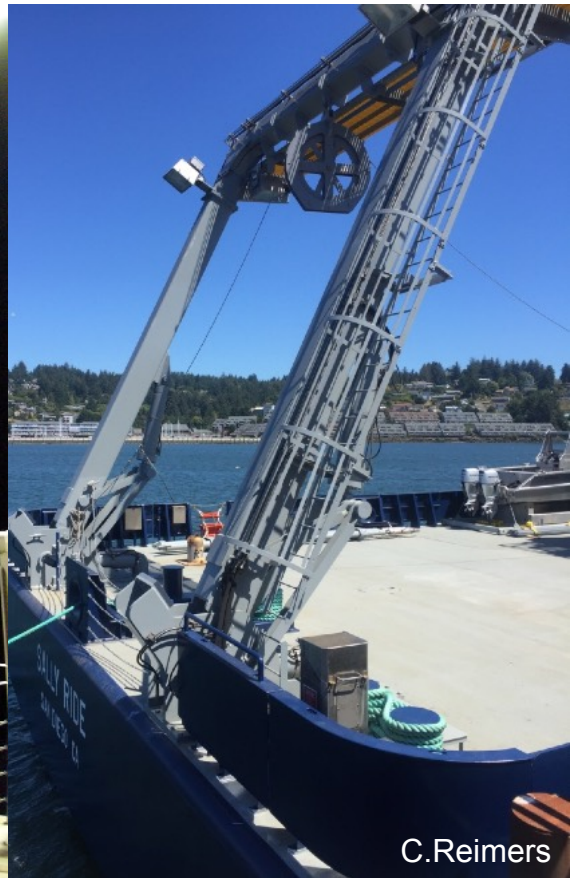
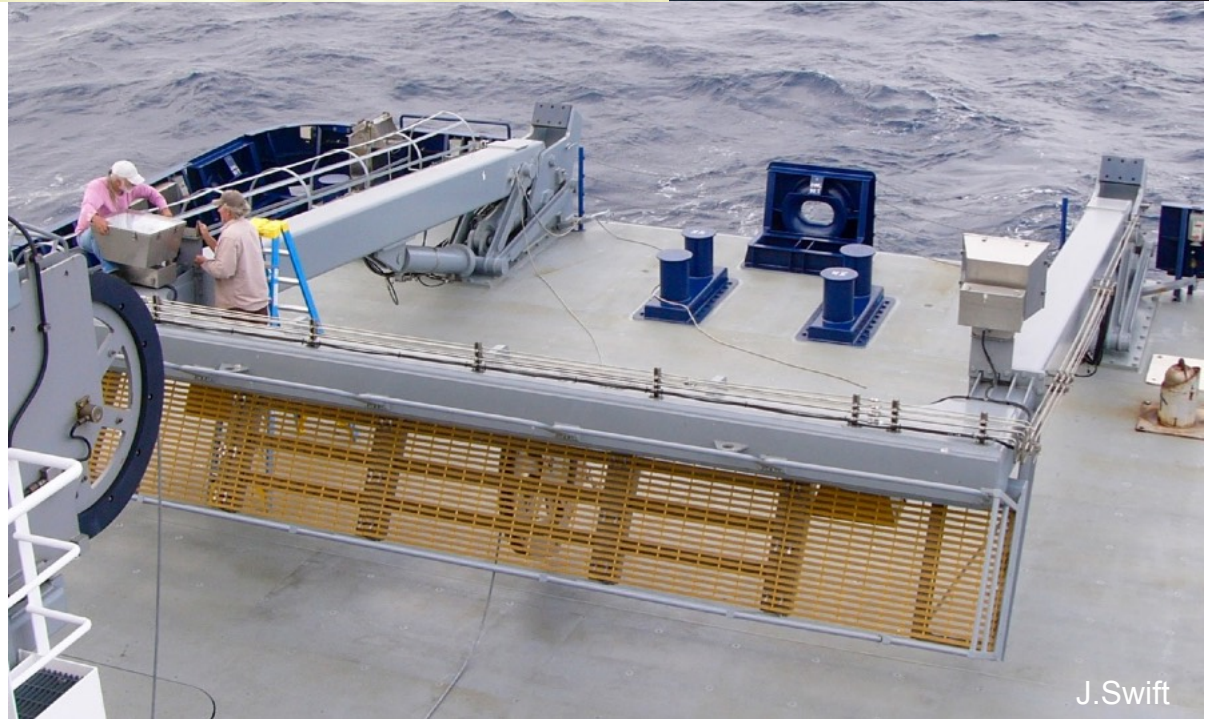
Figure 10. Aft A-Frame in Normal and Lay-Down Positions.

the fantail deck - this was done without difficulty for routine work during the winch test cruise (Figure 10). The fantail deck wraps around the starboard side of the ship to the launch/recovery points for the two articulating booms. There is some deck space on the starboard side for small winches and other temporary items. There are bolt holes on 2-foot centers throughout fantail areas where one would expect them. There are hatch covers over each of the trawl winch drums underneath the fantail, and a hatch cover over the engine room on the forward portion of the starboard side fantail extension. There is also a hatch cover just aft of that, over the science storeroom. There are two well-placed winch "scoreboard" screens that display wire out, wire speed and tension. In addition to the van service points, on other areas of the fantail there are fresh water and compressed air outlets, an outlet for the incubator water line, and marine outlets for 120-volt (at least 4), 240 volt (4), and 480-volt (4) electrical power. Night lighting on the fantail was very good to excellent: white, bright, relatively even in most locations, and relatively shadow free in most locations. The A-frame lights illuminated the deck well whether the boom was in standard inboard position or in outboard position, and illuminated the sea surface well in the outboard position, without being overly bright to eyes on the bridge in either A-frame position.

winch test cruise. Rail modifications, such as a swing-opening double gate, may be needed for larger diameter equipment.

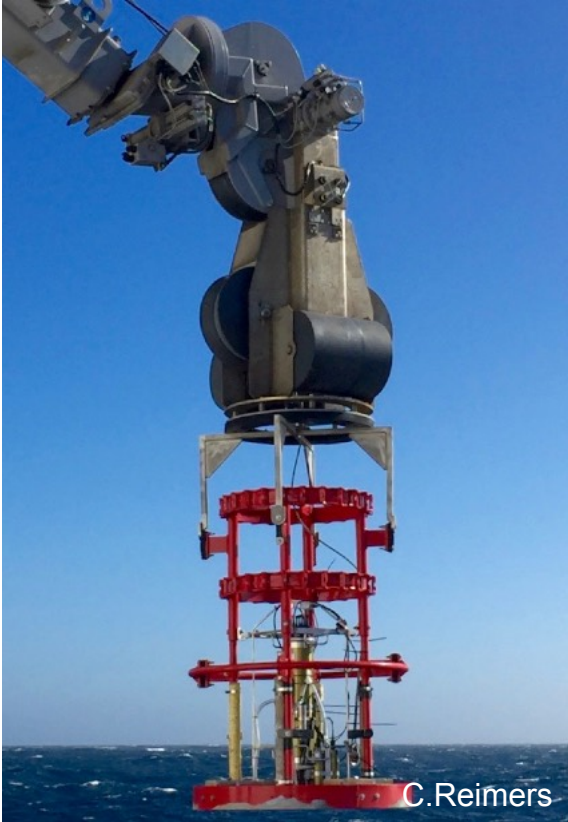
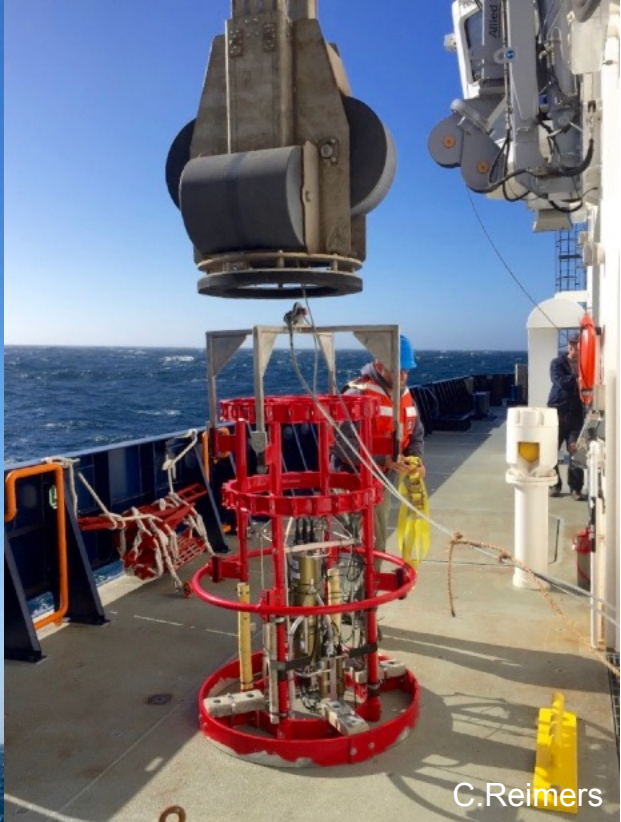
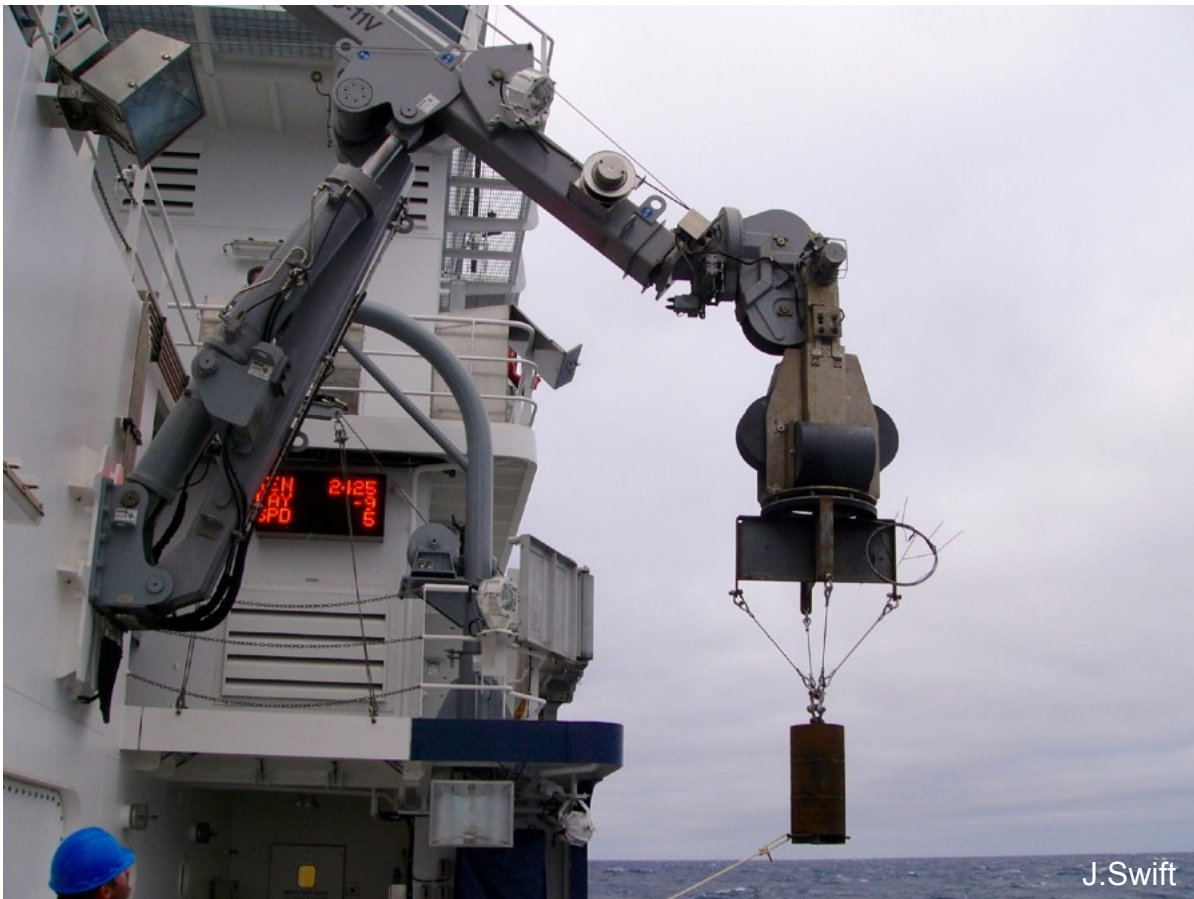
Figure 11. CTD Articulated/Extending Boom with Swivel Docking Head.

The deck-to-head vertical clearances for the two starboard articulating science booms are short due perhaps to the way these are mounted on the sides of the superstructure rather than on top of it. That distance is especially short (75 inches) for the CTD boom (Figure 11), which does not eyeball to be sufficient for a large rosette, especially it is landed on a pallet or cart as usual. (Even the small rosette used on the winch test cruise was a tight squeeze underneath the CTD boom when it was on its pallet.) The rail-to-boom-head vertical clearances also seem tight, but were not a problem with the small rosette used for the winch test cruise. The rail-to-boom-head clearance issue, if it developed, could be solved with rail modifications, such as a swing-opening double gate. It should be noted that the automatic launch and recovery features of the boom/winch systems performed flawlessly during the test cruise, as did the automated features of the winch in deploying and hauling in the science cables. There is a potential safety issue regarding hand-guiding the final few feet of extra CTD cable into the boom head when slack is taken up prior to rosette launch: a hand could get squeezed. This can (and will) be addressed via procedural changes and/or use of a hook or guide rather than a hand.
