SWAB REPORT #1101

SWAB DATE: September 10-11, 2024

R/V Kilo Moana & OTG Radioisotope Van

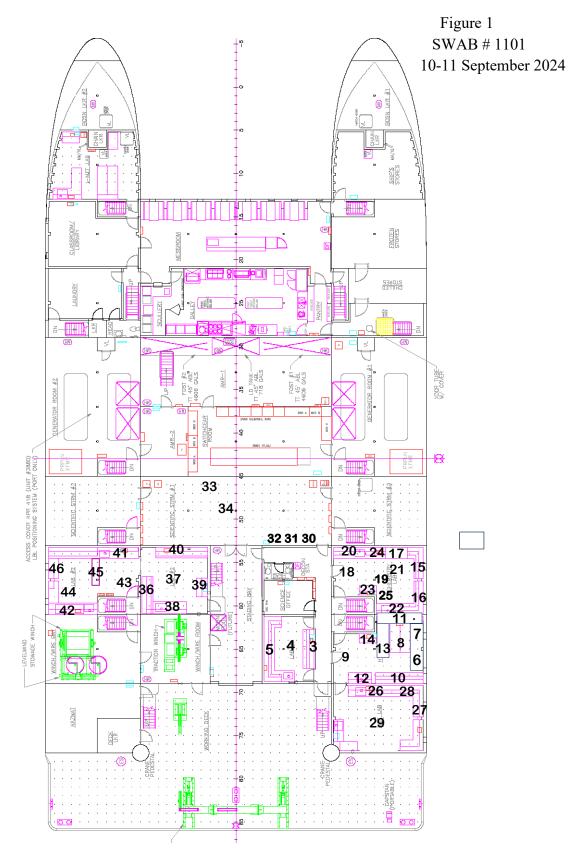
Sample #	Sample Identification	³ H dpm/m ²			¹⁴ C dpm/m ²		
1	· F	activity		error	activity		error
1	1st Vial Background	0	±	0	0	±	0
2	Initial bucket blank CO #1	1	±	4	15	±	13
	Lab #1 (Figure 1)						
3	Starboard benchtop	1	±	13	3	±	12
4	Deck in center of lab	-13	±	21	-3	±	16
5	Center section of port benchtop	-3	±	16	-10	±	13
	Hydro Lab (Figure 1)						
6	Starboard benchtop below forward porthole	4	±	10	10	±	12
7	Starboard benchtop below aft porthole	15	±	24	-2	±	7
8	Deck in front of starboard bench	8	±	17	7	±	12
9	Deck inside port entrance	-12	±	15	18	±	13
10	Aft benchtop	-15	±	24	23	±	14
11	Forward benchtop	-11	±	13	12	±	13
12	Aft sink area	-1	±	6	12	±	13
13	Port benchtop	-12	±	14	-4	±	12
14	Forward benchtop next to Fire Sta 17	-1	±	9	-2	±	10
	Chemistry Lab (Figure 1)						
15	Chem Lab F section of starboard benchtop	-11	±	13	3	±	14
16	Aft section of starboard benchtop	-26	±	21	1	±	4
17	Inside fume hood	2	±	9	5	±	12

18	Deck between forward sink & port entrance	-4	±	7	4	±	13
19	Center benchtop in front of aft sink	-16	±	26	10	±	14
20	Forward sink area	-2	±	35	5	±	12
21	Deck in front of fume hood	-6	±	12	-2	±	10
22	Aft sink and adjacent benchtop	-12	±	14	11	±	13
23	Aft benchtop next to Fire Sta 15	-38	±	21	-6	±	15
24	Forward benchtop between fume hood and sink	18	±	23	-1	±	17
25	Deck in front of aft sink	-6	±	317	12	±	13
	Wet Lab (Figure 1)						
26	Forward sink and adjacent benchtop	-21	±	17	21	±	14
27	Starboard benchtop	1	±	45	-1	±	5
28	Starboard side of fwd benchtop	-7	±	101	19	±	13
29	Deck port of CTD	-29	±	24	9	±	15

Sample #	Sample Identification	³ H dpm/m ²			¹⁴ C dpm/m ²		
-	-	activity		error	activity	•	error
	Science Storeroom (Figure 1)						
30	Inside Cospolich refrigerator #1	44	±	24	18	±	12
31	Inside Cospolich refrigerator #2	17	±	18	13	±	12
32	Inside Cospolich refrigerator #3	-24	±	19	0	±	2
33	Top of HOT freezer	1	±	3	18	±	13
34	Top of OTG freezer	0	±	1	13	±	13
35	Intermediate bucket blank	-21	±	17	5	±	16
	<u>Lab #2 (Figure 1)</u>						
36	Port benchtop	-32	±	23	15	±	14
37	Deck in center of lab	-34	±	24	1	±	2
38	Aft sink and adjacent benchtop	5	±	9	15	±	13
39	Starboard benchtop	14	±	17	11	±	12
40	Forward benchtop	1	±	3	15	±	13
41	Forward sink and adjacent benchtop	-6	±	25	25	±	14
42	Aft sink and adjacent benchtop	-44	±	24	37	±	15
43	Deck between aft entrance and forward sink	-7	±	23	28	±	14
44	Deck in front of aft sink	-2	±	5	18	±	13
45	Forward benchtop port of forward sink	-5	±	9	4	±	13
46	Port benchtop	30	±	26	0	±	3

Please note that the error reported for each isotope is the two-standard deviation counting error. Reports may now contain values less than zero. Decay counting background samples will be distributed about the background vial, which means that negative values are possible. In the past we rounded the negative values to zero. Values are only significantly above background when they are positive and larger than the error. Please note that we are now using a Quantulus 6220 LSC which counts very near natural background. While the cleanup standards have not changed; all values above background will now be in bold. All areas on the ship were free of radioisotope contamination that requires cleaning. Some minor ¹⁴C

was seen in the rad van. No action is necessary

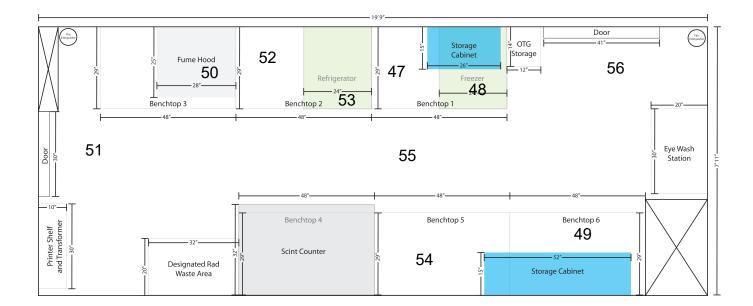
Figure #2 SWAB #1101 10-11 September 2024

OTG Radioisotope Van (Figure 2)						
47	Benchtop next to entrance	15	±	15	20	±	13
48	Inside refrigerator near entrance	76	±	28	19	±	11
49	Benchtop opposite front entrance	9	±	15	9	±	12
50	Inside fume hood	16	±	13	36	±	14
51	Deck inside rear entrance near fume hood	455	±	64	47	±	11
52	Benchtop adjacent to fume hood	490	±	61	70*	±	13
53	Inside refrigerator near fume hood	31	±	22	10	±	11
54	Benchtop adjacent to LSC	22	±	17	22	±	13
55	Deck between the two refrigerators	494	±	67	44	±	11
56	Deck inside front entrance	281	±	60	23	±	9
57	Final bucket blank	-23	±	19	14	±	14
