SWAB REPORT # 1102

R/V Atlantic Explorer
UNOLS Radioisotope Van #2408-04

REPORT FOR SWAB # 1102

LOCATION: St. Georges, Bermuda
VESSEL: *R/V Atlantic Explorer*

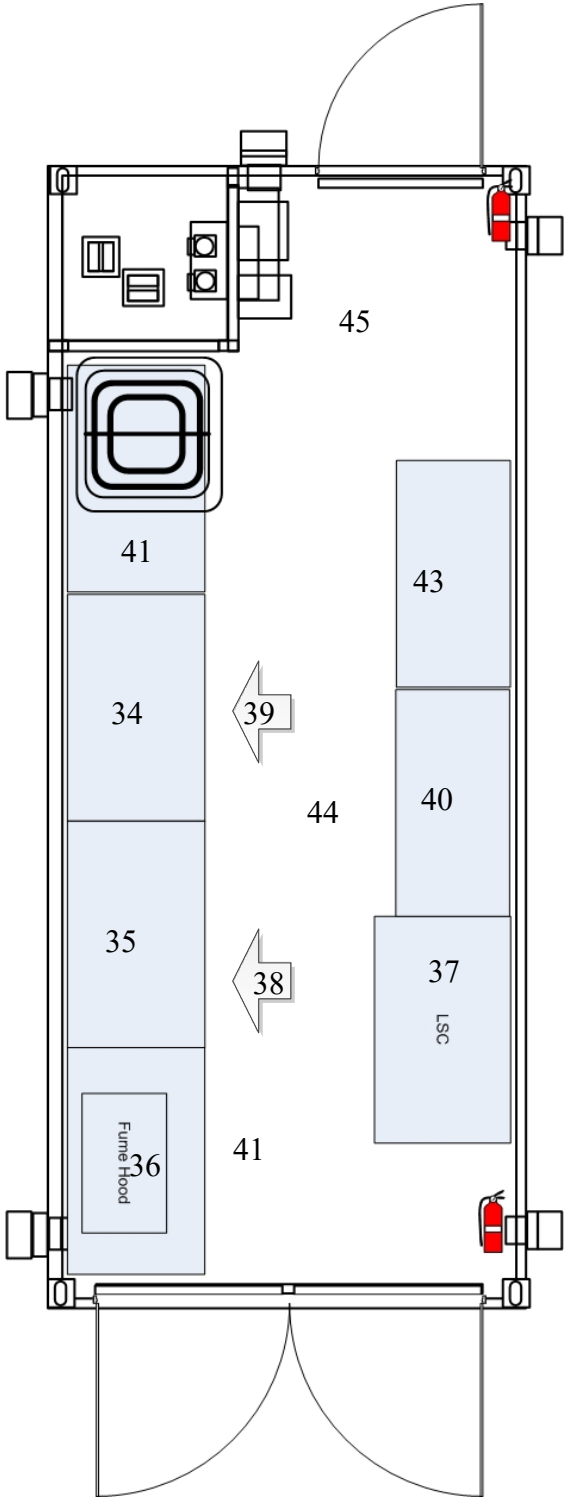
Figure 2
SWAB #1102
2 October 2024

Sample #	Sample Identification	³ H dpm/m ²		¹⁴ C dpm/m ²	
		activity	error	activity	error
31	Inside live Cospolich freezer	-16	± 28	13	± 15
32	Deck in front of -80 freezer #2	-31	± 54	9	± 16
33	CTD Bay port benchtop	7	± 22	1	± 8
<u>Radioisotope Van #2408-04 (Figure 2)</u>					
34	Benchtop adjacent to sink	3	± 7	-16	± 17
35	Benchtop adjacent to fume hood	28	± 23	9	± 12
36	Inside fume hood	-6	± 14	7	± 14
37	Top of LSC	64	± 31	-5	± 32
38	Inside freezer	-19	± 33	-17	± 18
39	Inside refrigerator	91	± 33	1	± 3
40	Benchtop adjacent to LSC	84	± 31	13	± 11
41	Deck in front of fume hood	91	± 31	22	± 12
42	Sink area	-25	± 42	3	± 21
43	Benchtop across from sink	-26	± 45	-4	± 25
44	Deck in center of van	59	± 29	7	± 10
45	Deck inside entrance	-19	± 32	5	± 17
46	Final bucket blank	-9	± 15	2	± 17

Please note that the error reported for each isotope is the two-standard deviation counting error. Reports may now contain values less than zero. Decay counting background samples will be distributed about the background vial, which means that negative values are possible. In the past we rounded the negative values to zero. Values are only significantly above background when they are positive and larger than the error. Please note that we are now using a Quantulus 6220 LSC which counts very near natural background. While the cleanup standards have not changed all values above background will now be in bold. All areas sampled inside the ship and in the Rad van free from contamination requiring cleaning.
