Two Ships / Two Centuries

Archaeological Research at

Yorktown and

Cape Hatteras

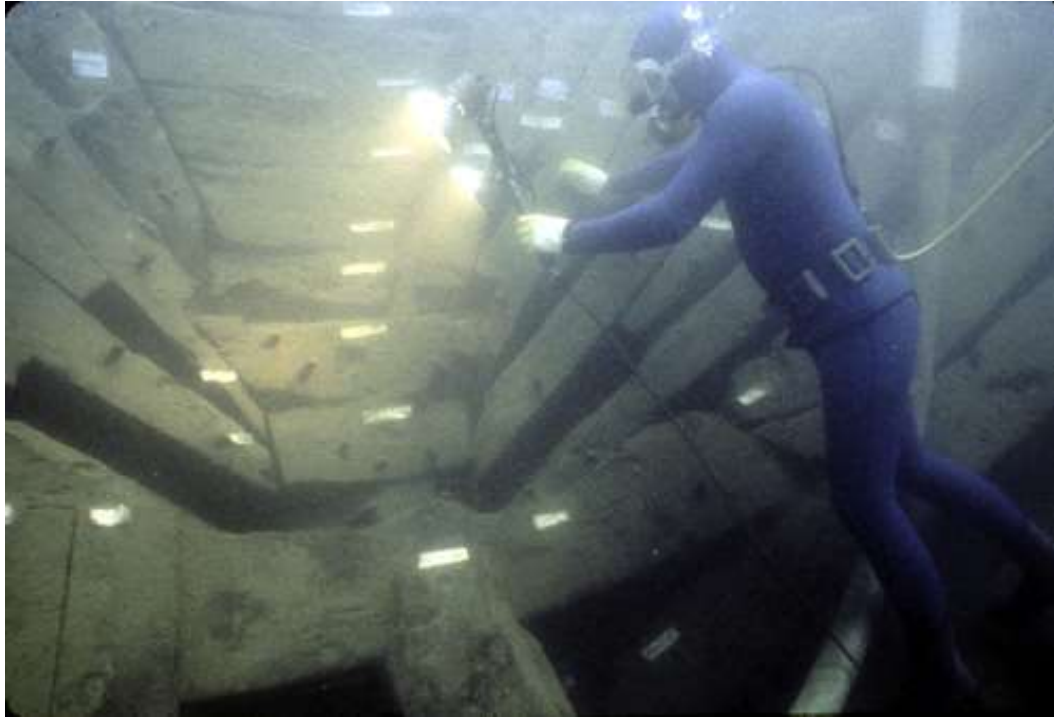
Structural Features

Unique bow structure

Pump box and mainmast

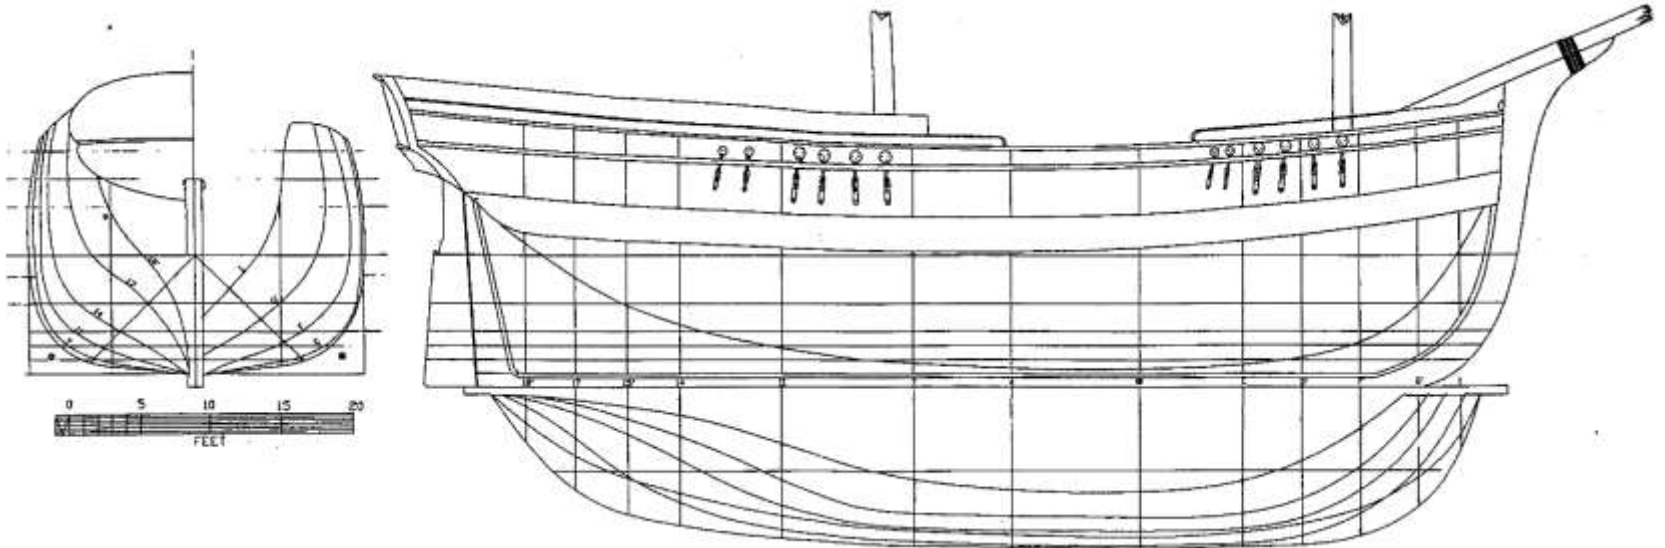
Lines: plumb bob \rightarrow computer \rightarrow splines & ink

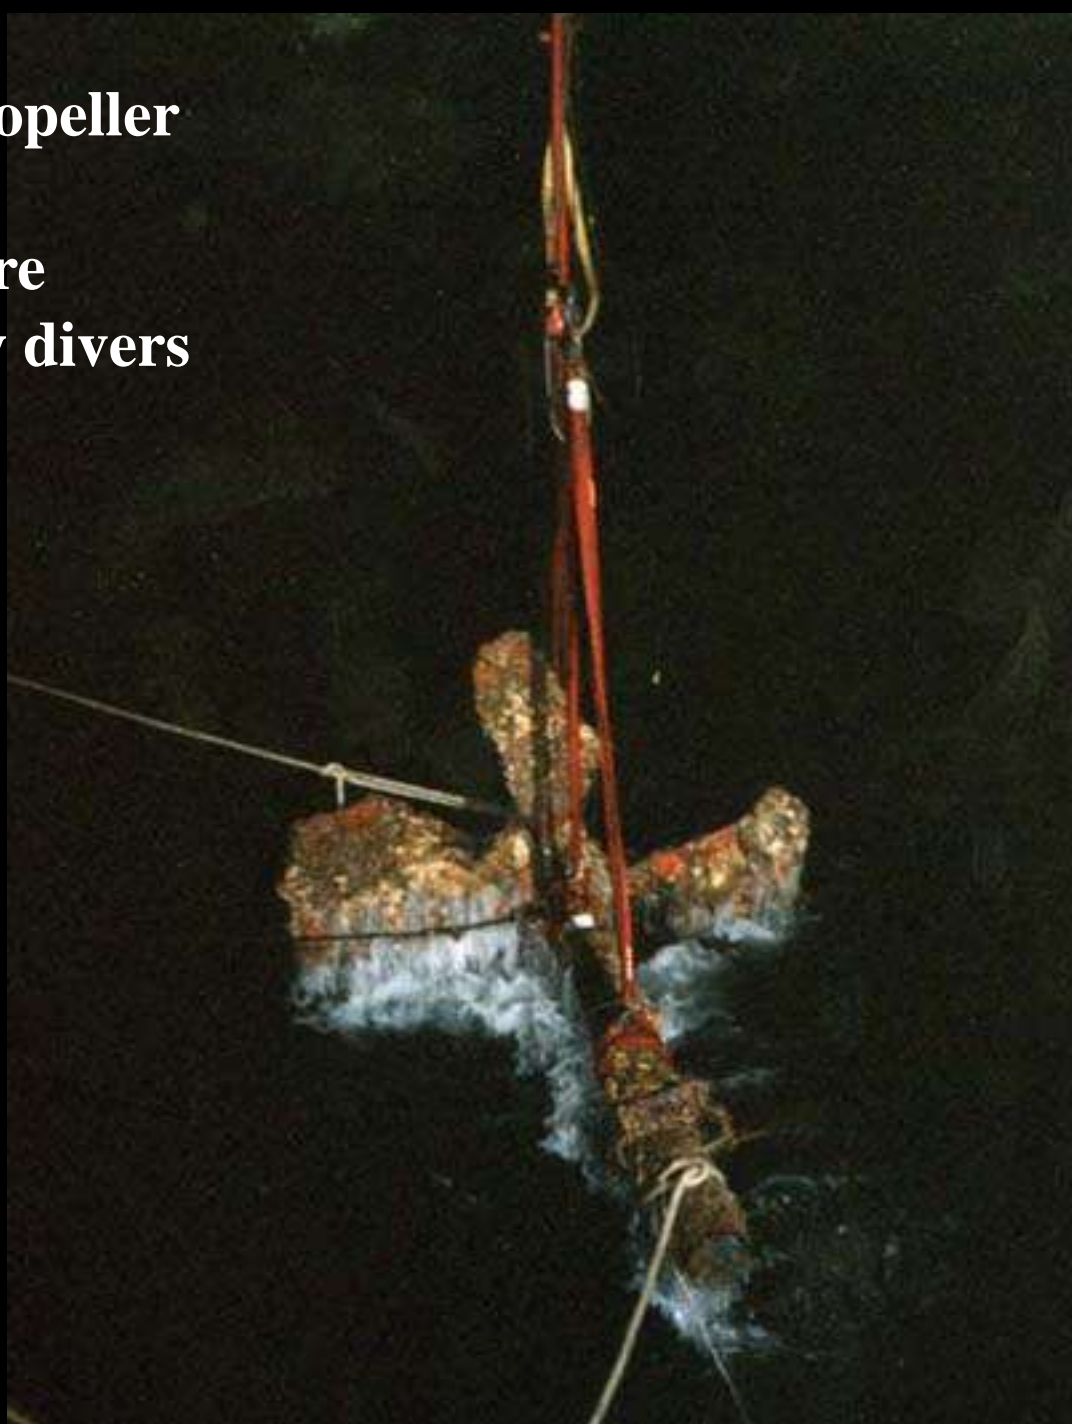
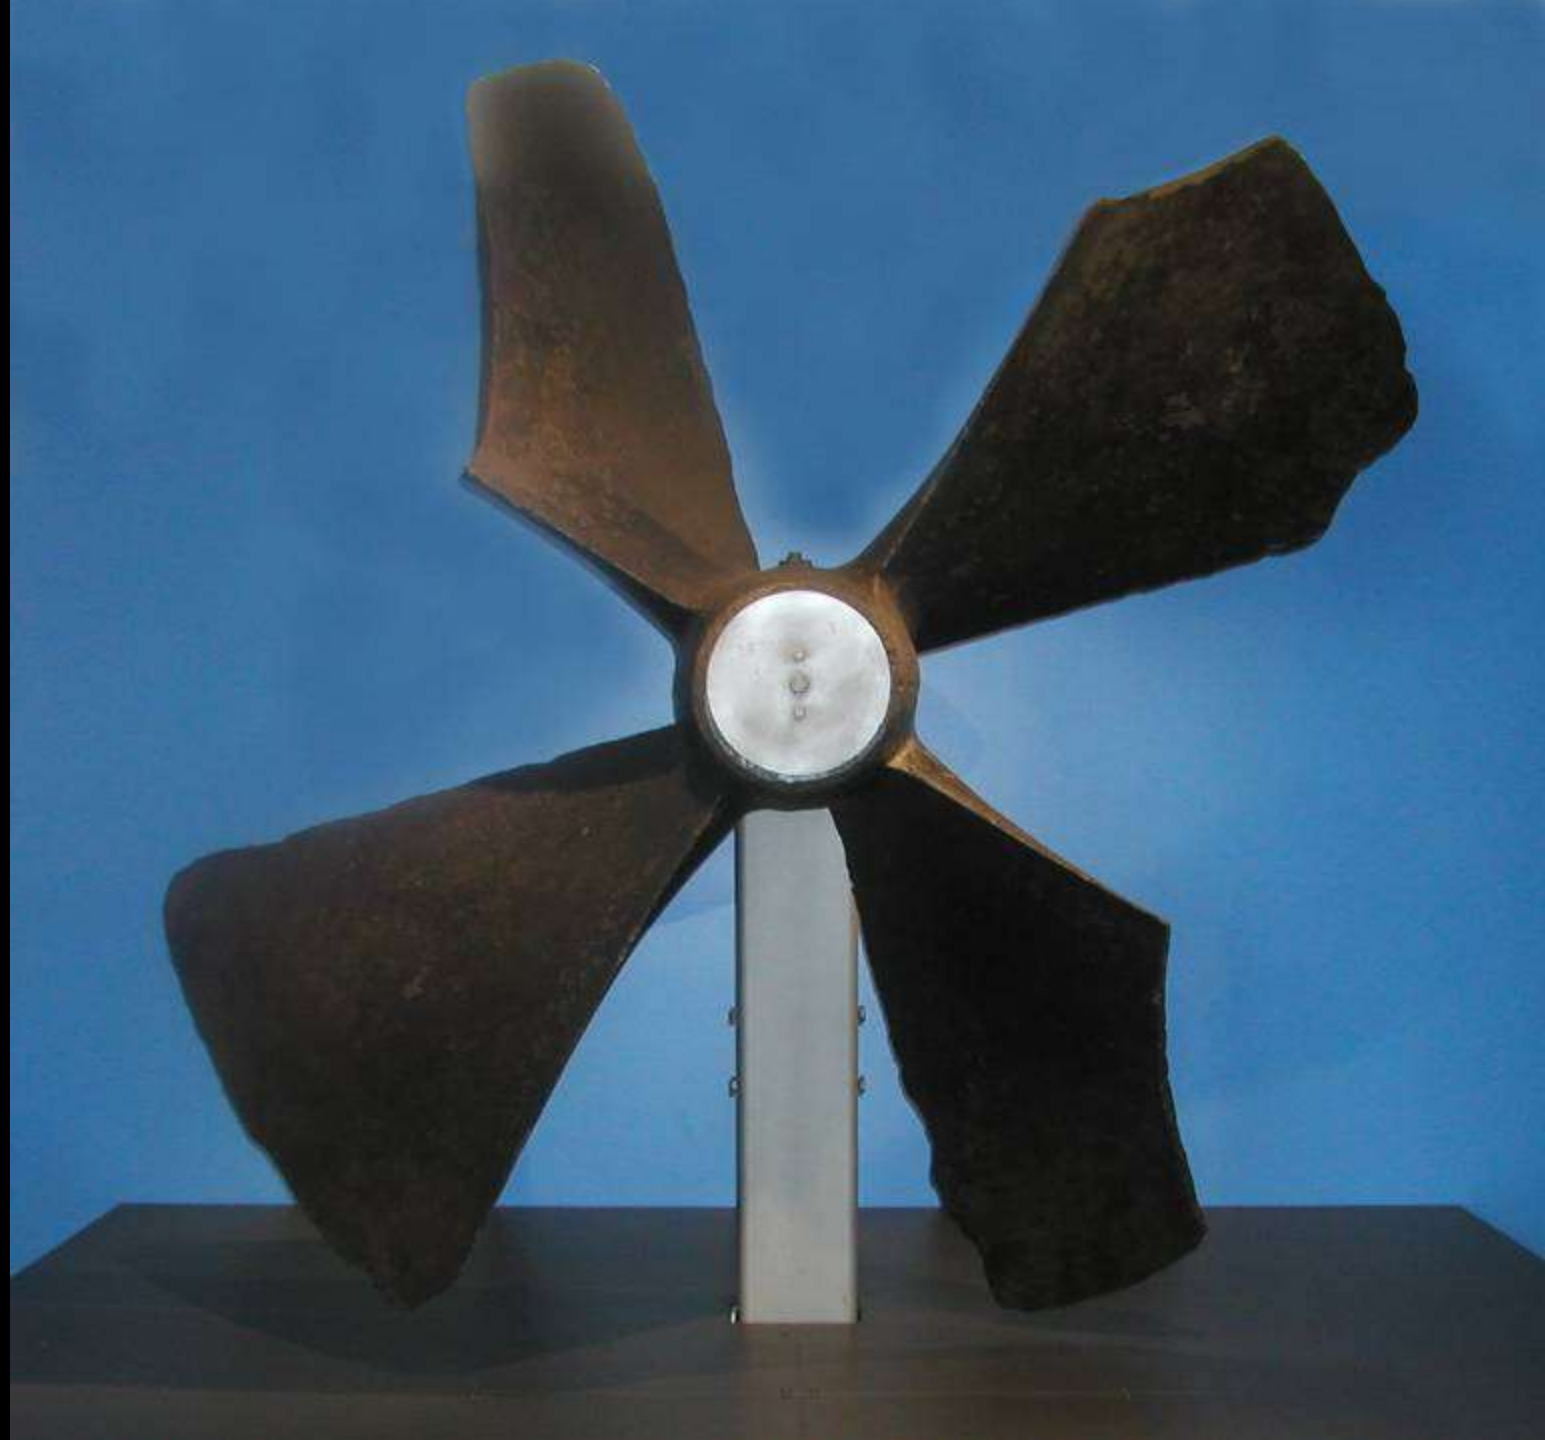
Propeller Recovery

**June 1998: the propeller
and eleven feet of
propeller shaft were
recovered by Navy divers**

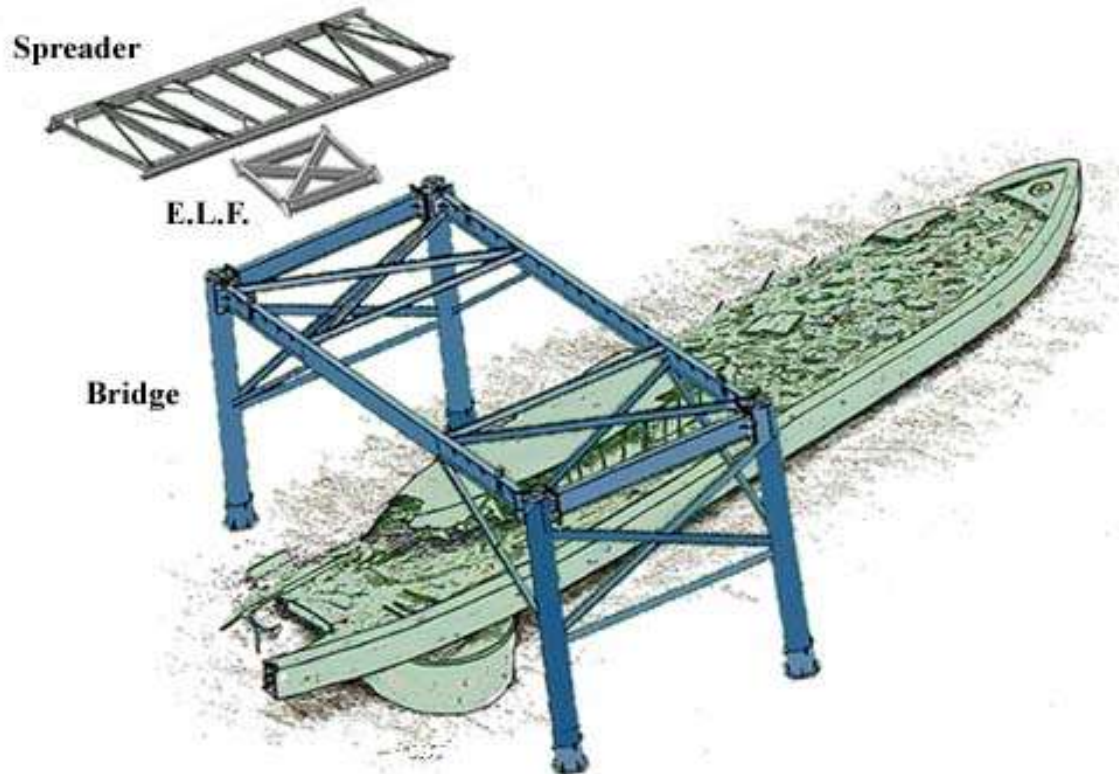
The Engine Recovery Structure

Installed in summer 2000

The three main components of the engine recovery structure (ERS).
