SWAB REPORT #1100

SWAB DATE: 3 August 2024

R/V Atlantis & Rad Van #625.6.03

REPORT FOR SWAB #1100

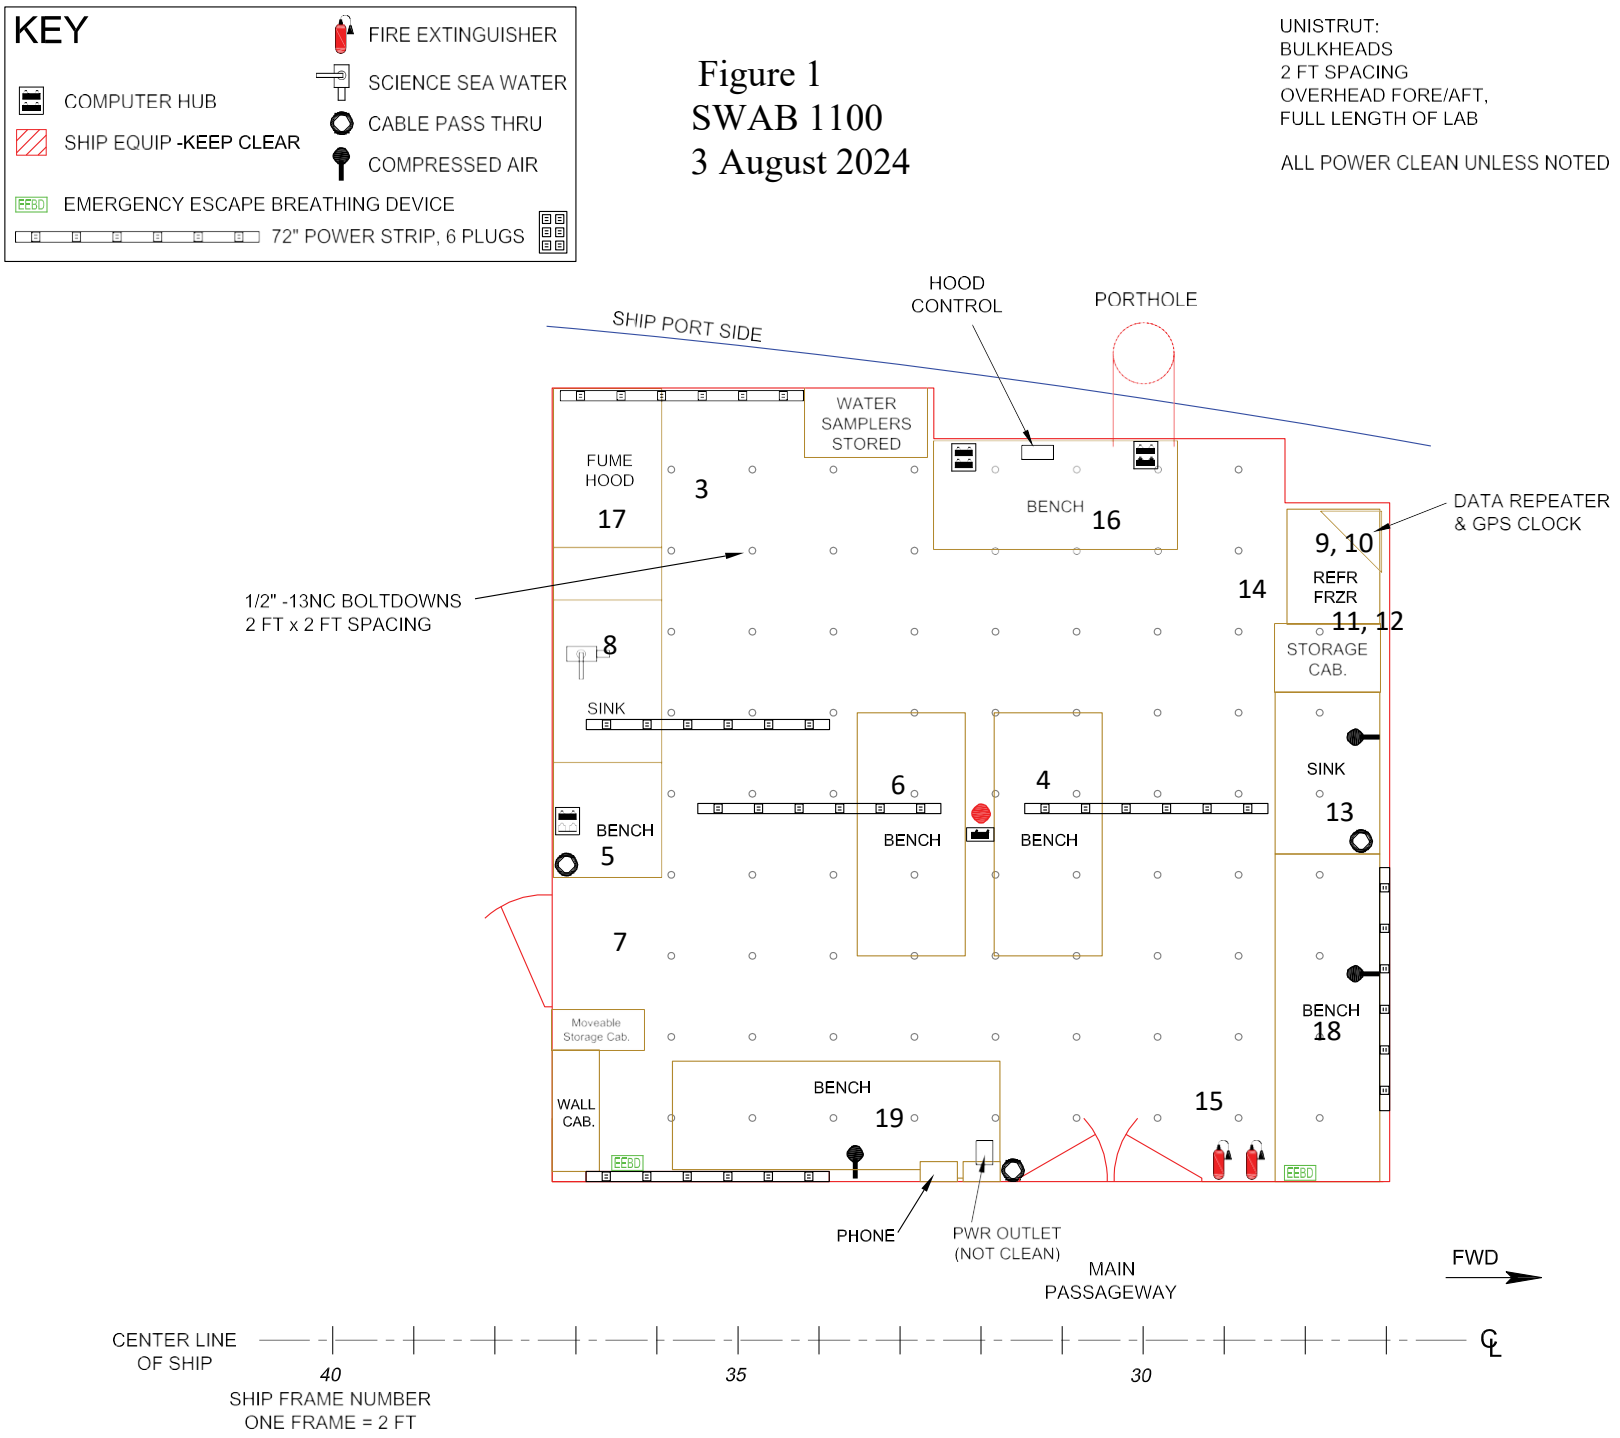
BIOLOGICAL/ANALYTICAL CLEAN LABORATORY

Sample #	Sample Identification	^{3}H dpm/m^{2} activity	±	^{3}H dpm/m^{2} error	^{14}C dpm/m^{2} activity	±	^{14}C dpm/m^{2} error
1	1st Vial Bkgnd	0	±	0	0	±	0
2	Initial bucket blank	-29	±	20	2	±	51
	<u>Bio-Analytical Lab (Figure 1)</u>						
3	Deck in front of fume hood	-14	±	94	**36**	±	**16**
4	Benchtop across from forward sink	18	±	24	3	±	11
5	Benchtop adjacent to aft sink	-15	±	54	**45**	±	**16**
6	Benchtop across from aft sink	-13	±	11	**99***	±	**19**
7	Deck inside aft entrance	3	±	4	**31**	±	**15**
8	Aft sink area	-39	±	127	**98***	±	**19**
9	Inside Cospolich refrigerator	-28	±	54	6	±	18
10	Inside Cospolich freezer	-13	±	13	**87***	±	**18**
11	Inside Frigidaire refrigerator	-33	±	26	**150***	±	**21**
12	Inside Frigidaire freezer	-21	±	29	**17**	±	**15**
13	Forward sink area	-17	±	65	**16**	±	**15**
14	Deck in front of refrigerators	**9**	±	**7**	**52***	±	**16**
15	Deck inside starboard entrance	-33	±	25	-8	±	12

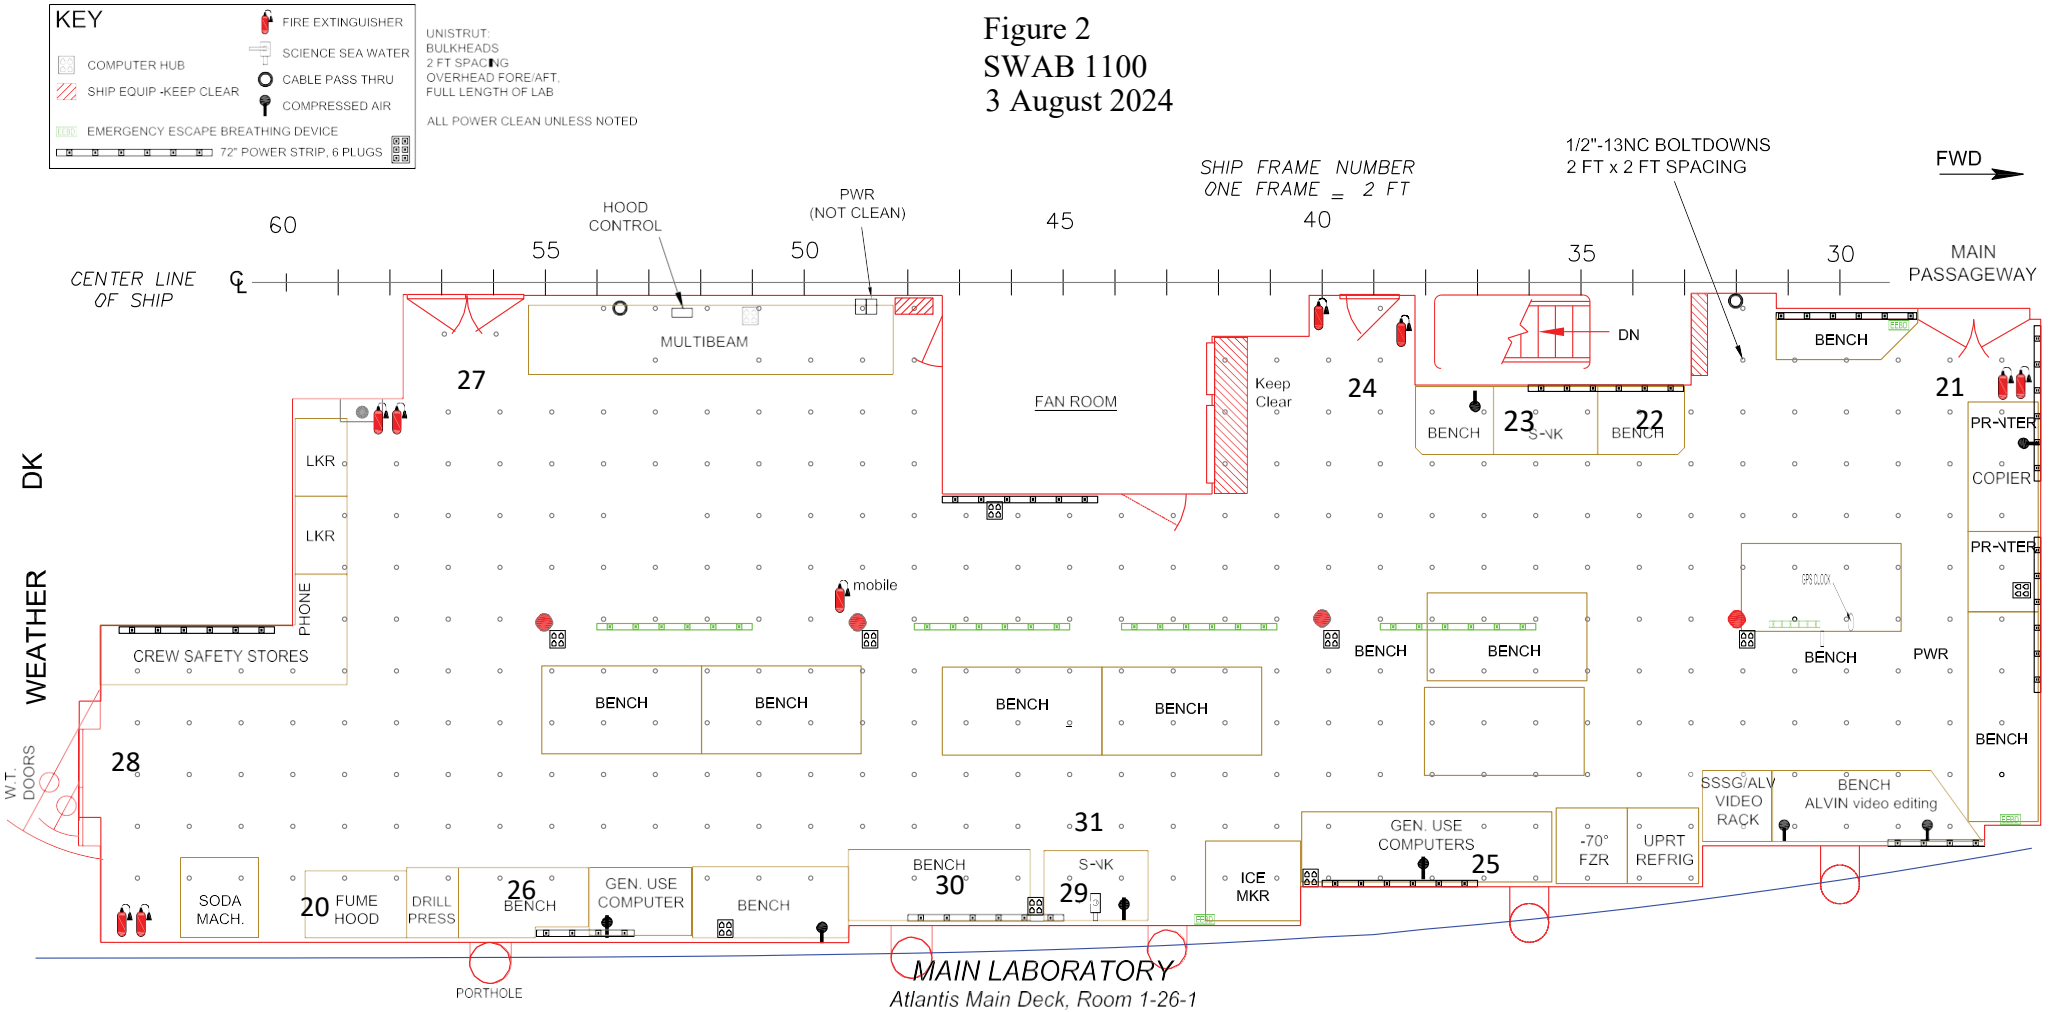
Figure 2
SWAB 1100
3 August 2024

16	Port benchtop	5	±	21	-16	±	15
17	Inside fume hood	-34	±	26	5	±	21
18	Forward benchtop	-10	±	9	3	±	17
19	Starboard benchtop	-2	±	2	-18	±	17
	<u>Main Lab (Figure 2)</u>						
20	Inside fume hood	-32	±	25	0	±	1
21	Deck inside forward port entrance	19	±	24	4	±	11
22	Benchtop adjacent to port sink	-34	±	27	-8	±	11
23	Port sink area	-50	±	21	1	±	2
24	Deck inside port entrance located aft of sink	-22	±	30	4	±	19
25	Starboard benchtop forward of ice machine	20	±	38	-13	±	20
26	Starboard benchtop forward of fume hood	-1	±	6	7	±	14
27	Deck inside aft port entrance	-5	±	25	**20**	±	**15**
28	Deck inside aft entrance	-40	±	17	12	±	17
29	Starboard sink area	-21	±	28	-7	±	11
30	Benchtop aft of starboard sink	-14	±	97	0	±	1
31	Deck in front of starboard sink	0	±	3	5	±	14
	<u>Miscellaneous Areas (Figure 3)</u>						
32	Deck between walk in coolers	-18	±	25	13	±	15
33	Deck ouside entrance of Science Storeroom	-20	±	27	15	±	16

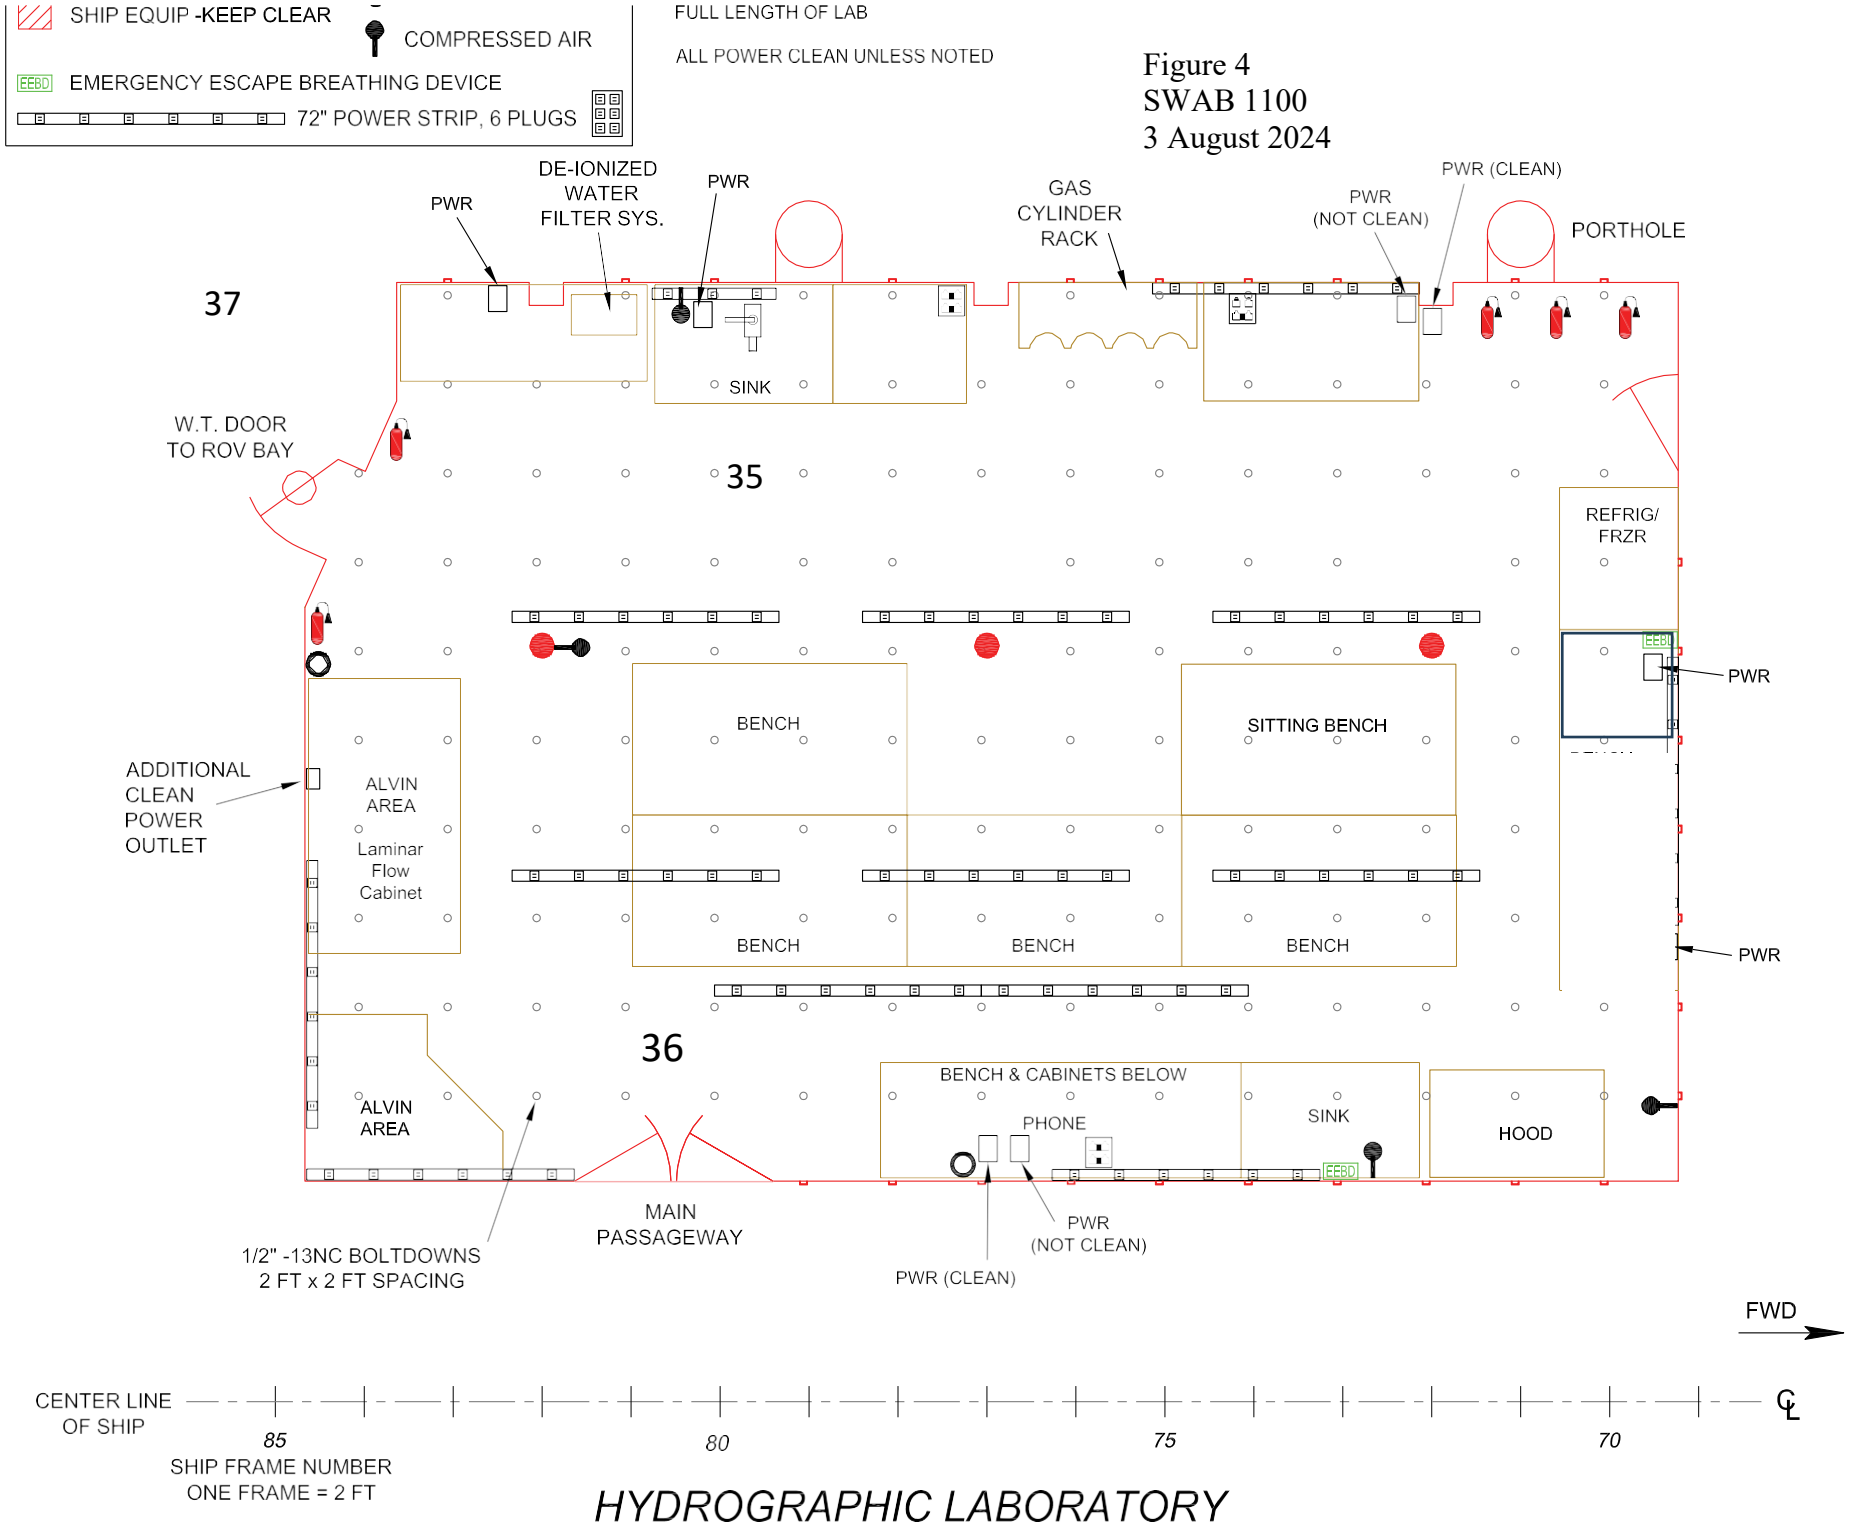
HYDROGRAPHIC LABORATORY

Sample #	Sample Identification	^{3}H dpm/m^{2} activity	error	^{14}C dpm/m^{2} activity	error
	Hydro Lab (Figure 4)				
35	Deck in front of port sink	-56 ±	24	1 ±	2
36	Deck inside starboard entrance	-10 ±	70	5 ±	15
37	Deckaround the sink in ROV bay	-26 ±	50	15 ±	16
38	Intermediate bucket sample	-27 ±	51	-12 ±	18
	Wet Lab (Figure 5)				
39	Starboard benchtop	-31 ±	24	-3 ±	10
40	Inside fume hood	-15 ±	56	-8 ±	12
41	Port benchtop	13 ±	97	-21 ±	14
42	Forward sink area with wood benchtops	-29 ±	56	-5 ±	21
43	Deck inside starboard entrance	-2 ±	14	10 ±	14
44	Deck inside aft entrance	3 ±	5	**26 ±**	**15**
45	Deck inside port entrance	7 ±	10	**27 ±**	**15**
	Radioisotope Van #625.6.03 (Figure 6)				
46	Inside ATVIO refrigerator under bench	**71 ±**	**30**	**19 ±**	**13**
47	Inside fume hood	**349 ±**	**52**	**90* ±**	**16**
48	Benchtop adjacent to fume hood	**174 ±**	**32**	**221* ±**	**23**
49	Benchtop above ATVIO & Haier refrigerators	**486 ±**	**48**	**711* ±**	**37**
