R/V Sally Ride Cruise SR1603 Chief Scientist's Report

James H. Swift, UCSD Scripps Institution of Oceanography
11-20 August 2016

Observations re R/V Sally Ride August 2016

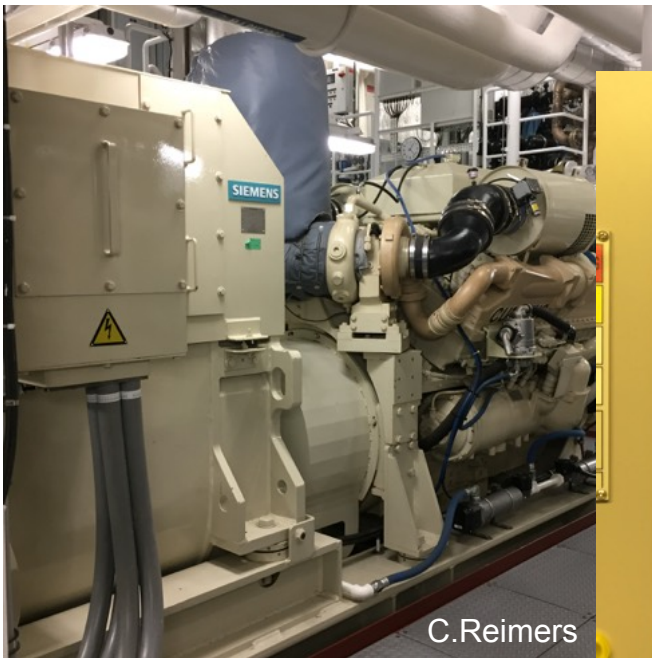
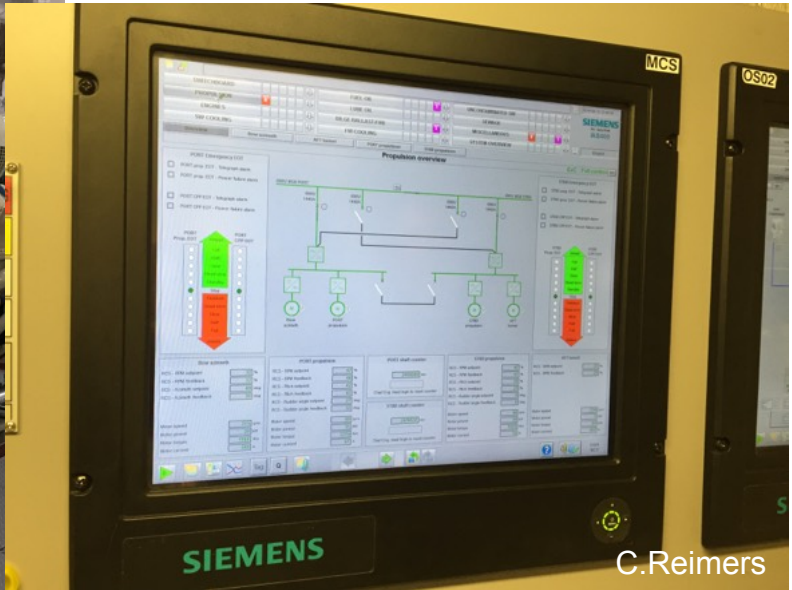
Figure 12. Engine Room

A thorough tour of the engine room complex, led by Chief Engineer Paul Bueren, revealed care and consideration in construction and outfitting, what in some ways could be described as an engineering work of art (Figure 12). It is an engine room of the 21st century with twin AC motors controlled electronically by four Siemens variable frequency drive generator systems and propelling two controllable pitch propellers, stern and bow thrusters, and a pair of rudders. The engine room/machinery space also houses the essential elements of a modern marine sanitation device, an oily water separator, a UV ballast water treatment system, reverse osmosis fresh water maker and a small workshop area. Piping throughout these spaces appeared of high quality, but space around devices and control panels was limited.

Figure 12. R/V Sally Ride engine room, including one of the ship's generators and a propulsion system display.
